Exhaust Hose Assembly

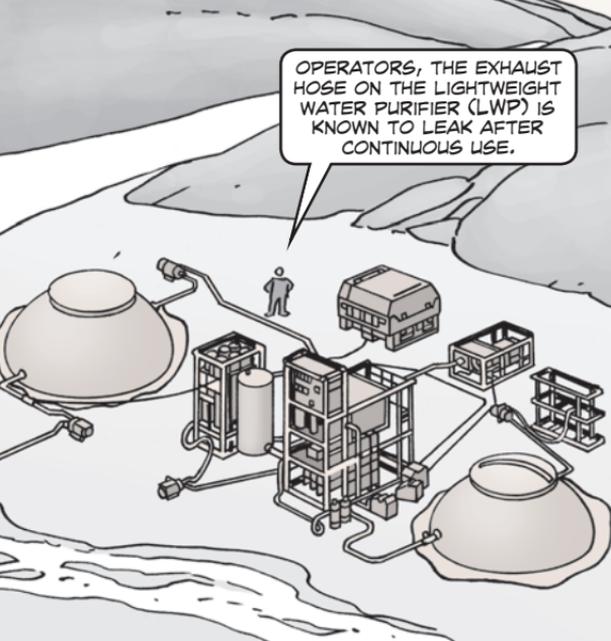
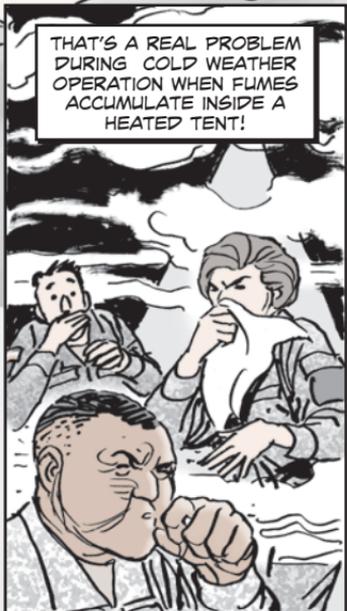
OPERATORS, THE EXHAUST HOSE ON THE LIGHTWEIGHT WATER PURIFIER (LWP) IS KNOWN TO LEAK AFTER CONTINUOUS USE.

THAT'S A REAL PROBLEM DURING COLD WEATHER OPERATION WHEN FUMES ACCUMULATE INSIDE A HEATED TENT!

SO-O-O, HAVE YOUR MECHANIC REPLACE A LEAKY HOSE WITH A NEW HOSE ASSEMBLY (THE HOSE AND CLAMP) THAT COMES WITH NSN 4720-01-567-1009.

THE HOSE IS SHOWN IN FIG 7 OF WP 0018-6 OF TM 10-4610-310-13.
