BURST BRAKES A REAL BUMMER

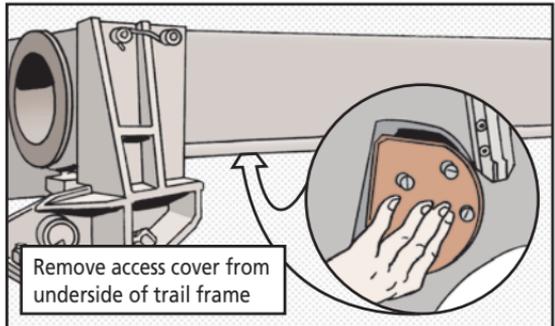
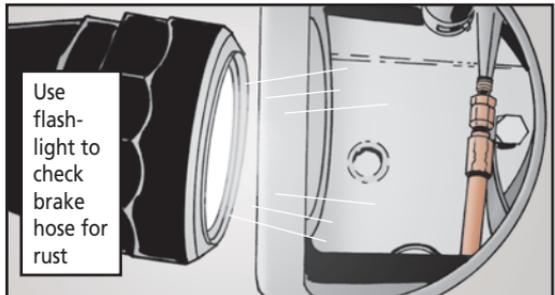
While performing scheduled services, we've noticed that the M119A2's brake hose, NSN 4720-01-344-6034, is badly rusted about 80 percent of the time. Those rusty hoses can easily burst during brake tests and normal operation.

The brake hose is easy to reach. Just open the right-hand (curbside) access cover, PN 12591232, on the underside of the trail frame. Then use a flashlight to look at the brake hose inside the frame chamber. If it's rusty, get the brake hose replaced right away.

We recommend that operators keep a close eye on this brake hose and that it also be checked during every service.

Editor's note: An excellent suggestion, gentlemen. The procedure for replacing the brake hose is in WP 0045 00 of TM 9-1015-252-34 (Aug 06, w/Ch 1, Feb 08).
