# FIRE PREVENTION!

Please put the word out that a loose or incorrectly mounted E1 grounding wire inside the electrical connector assembly, NSN 5935-01-360-2630, of the MT-6352/VRC can burn out the EMI filter or the wiring.

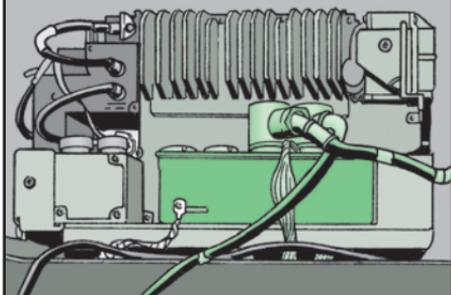
When repairing, check terminal lug!

So, when doing repairs of the electrical connector assembly, be sure that the E1 ground wire terminal lug is securely fastened to the EMI filter mounting screw. The screw is located near the end of the electrical connector. If the screw is missing, order a new one with NSN 5305-01-303-0311. And get a new washer with NSN 5310-01-540-5271.

*Editor's note:* Thanks, David, for this important info. Maintainers, remember to do a continuity check to verify the ground when you replace or tighten the screw.
