**M**echanics, the Axis A oil nozzle on the UH-60 and the AH-64 engines requires special attention.

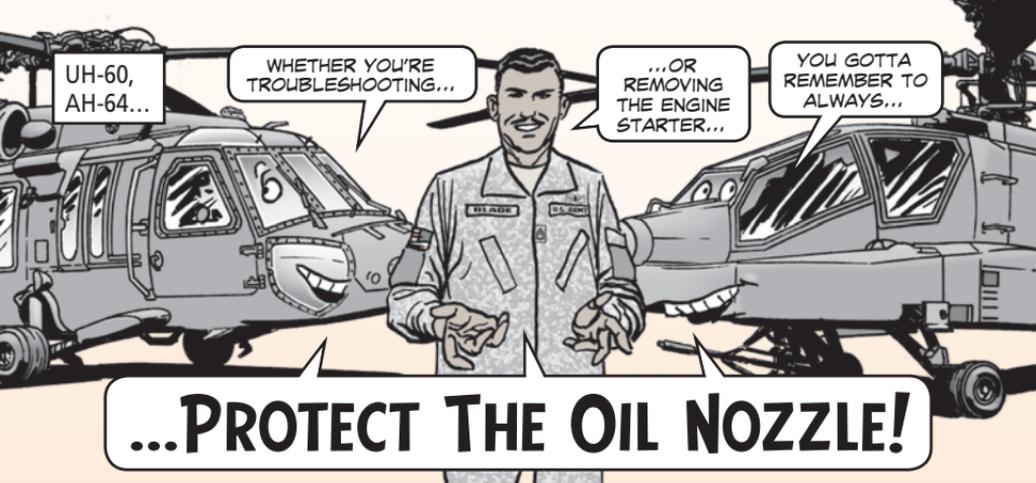
Use extreme caution when removing and installing the Axis A cover assembly to avoid contact and damage to the Axis A oil nozzle. Remove the engine coupling retaining bolt and hold the radial drive shaft assembly using a ratchet with a  $\frac{1}{4}$ -in drive adapter and a  $\frac{5}{16}$ -in socket to prevent turning when removing the bolt.

The nozzle has a very tiny hole to spray oil through. The slightest damage to the oil nozzle means it won't be able to provide oil to the radial drive shaft and the Axis A bearing in the gearbox.

Then the engine oil pressure drops, starving the radial drive shaft and the bearing assembly of oil. You could end up replacing a burned-out gearbox caused by a lack of oil.

Keep an eye on the Axis A oil nozzle when hand cranking the engine to identify symptoms and corrective actions during troubleshooting or when replacing the engine starter.

As you place the  $\frac{1}{4}$ -in drive adapter on the radial drive shaft to keep it from turning, make sure that it does not hit the oil nozzle or rest against it. The removal, replacement and installation instructions are in WP 0695 of TM 1-1520-237-23.

Steer clear of the Axis A oil nozzle when replacing the engine starter and you'll avoid major engine repair. Also, to prevent oil loss and possible in-flight shutdown, make sure the Axis A cover assembly is reinstalled correctly. Check out the instructions in WP 0398 of TM 1-2840-248-23&P.
