RELIEVE THE PRESSURE

Most people don't work well under a lot of pressure. The same holds true for the roadwheels on your M88A1 recovery vehicle, crewmen.

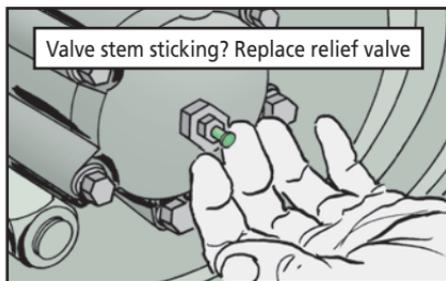
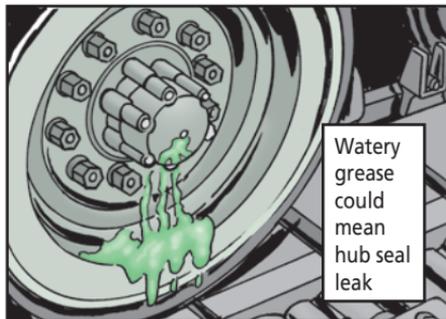
A roadwheel relief valve that's clogged with dirt and sand won't relieve pressure when you pump in new grease. The pressure grows until something gives—usually the hub seal.

When the seal goes, so does the lube. The result is burned-out bearings.

So before adding new grease, use a cloth to wipe away any dirt and sand from the relief valve. Then pull out the valve stem.

If it slides out smoothly and pops back in when you release it, the valve's OK. If it doesn't, replace it with NSN 4820-01-070-7670.

Now that the roadwheel's ready for lubing, pay close attention to the first grease that appears from the relief valve. If the grease is gritty or watery, it could be that sand and water are getting in past the hub seal.

Stop and call your mechanic. New grease won't help until the bearings are disassembled, cleaned and repacked and a new seal is installed.
