M1000
HET
Semi-
Trailer...

DRAIN WATER BEFORE IT FREEZES!

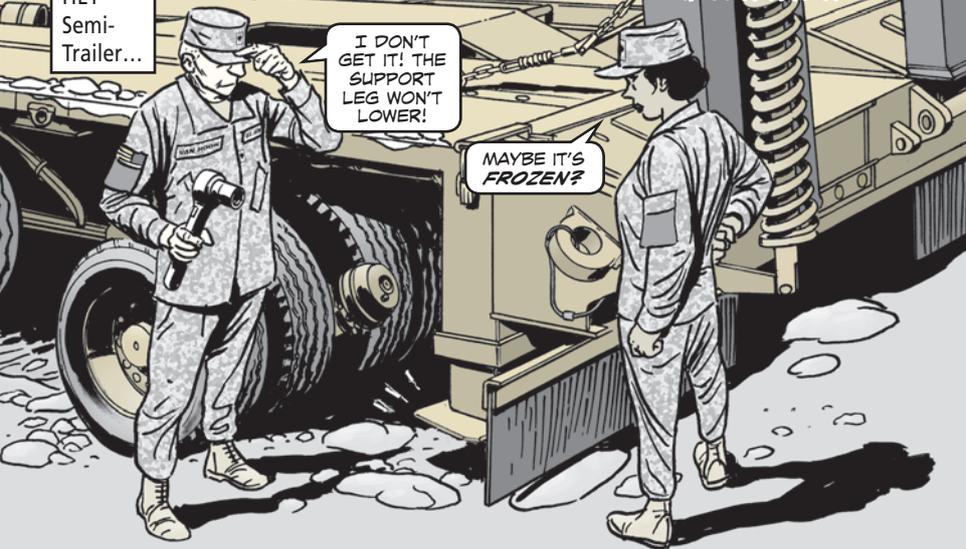
I DON'T GET IT! THE SUPPORT LEG WON'T LOWER!

MAYBE IT'S FROZEN?

We've been having problems with the rear support legs seizing up on our HET trailers.

It turns out that water is seeping past the drive screw and into the inner tube of the support leg. During cold weather, that water freezes and expands the tube enough that it's almost impossible to raise or lower.

We fixed this problem by drilling two drain holes at the bottom of each support leg. Here's how:

Lower the support leg all the way to the ground.

Using a 1/2-in bit, drill one drain hole through the outboard wall of the inner retract tube on both the curb and street sides of the support leg.

Center the holes and drill them 1 inch above the top of the foot plate.

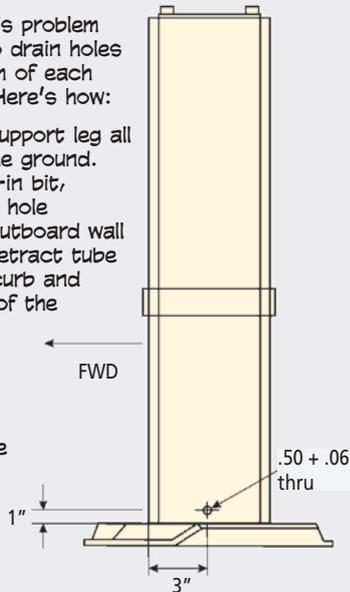
Water seeps past drive screw and into support leg

Avoid drilling holes on the front or back of the support leg. Dirt and mud will just get into the holes and plug them.

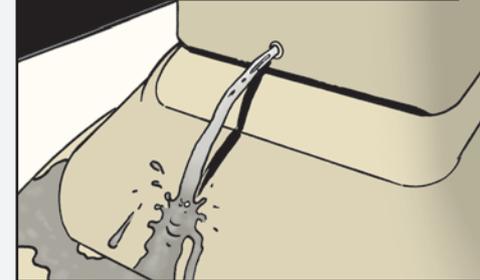
Drain holes release water before it can freeze

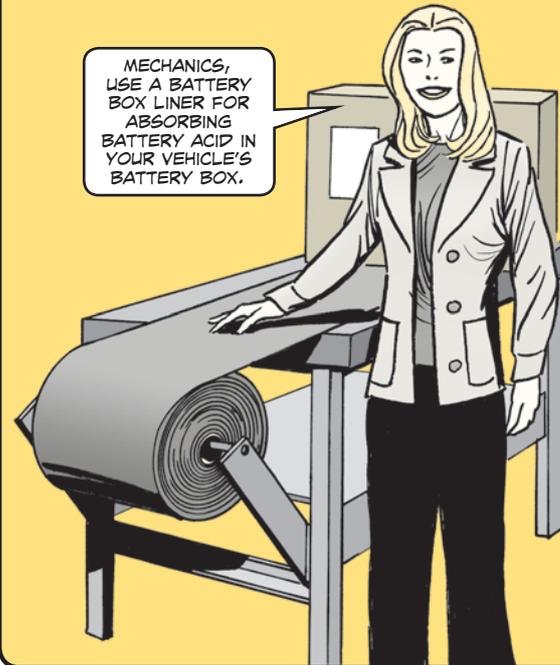
MECHANICS,
USE A BATTERY
BOX LINER FOR
ABSORBING
BATTERY ACID IN
YOUR VEHICLE'S
BATTERY BOX.

You need it because the liner will not only absorb battery acid but neutralize it as well.

Get a roll of 1/4-in thick liner with NSN 6160-01-389-1966. Cut it to the dimensions you need to line a vehicle's battery box. This 13-in x 100-ft roll of liner will take care of all the vehicles in your unit's motor pool... and then some.

Change the liner when it becomes soaked with battery acid or starts to deteriorate.
