M1-Series Tanks...

ENGINE GETS MORE STUDLY

ANTENNA NEEDS COVER, TOO

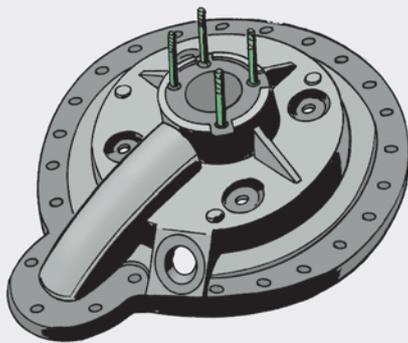
Studs, NSN 5307-01-588-8862, are now available to replace the four bolts that currently secure the fuel nozzle to the combustor cover. The studs help align and hold the fuel nozzle in place during installation. The studs also work with both the old and new configurations.

New studs help align and hold fuel nozzle

Screw the studs into the combustor cover. Drop the fuel nozzle in place and add a flat washer, NSN 5310-01-352-9593, and a self-locking, silver-plated nut, NSN 5310-00-844-4872, to the top of each stud to secure the fuel nozzle. Torque the nuts to 90-100 lb-in.

Since the working threads on the studs are now in a cooler location (300°F at the top of the studs vs. 700°F inside the combustor cover), the threads are less likely to seize during semi-annual maintenance.

The next time you need to remove and reinstall the fuel nozzle, the flat washers can be reused. So can the original self-locking nuts as long as the self-locking feature is still in good shape. If the nuts can be finger-tightened, the self-locking feature is worn out and the nuts must be replaced.

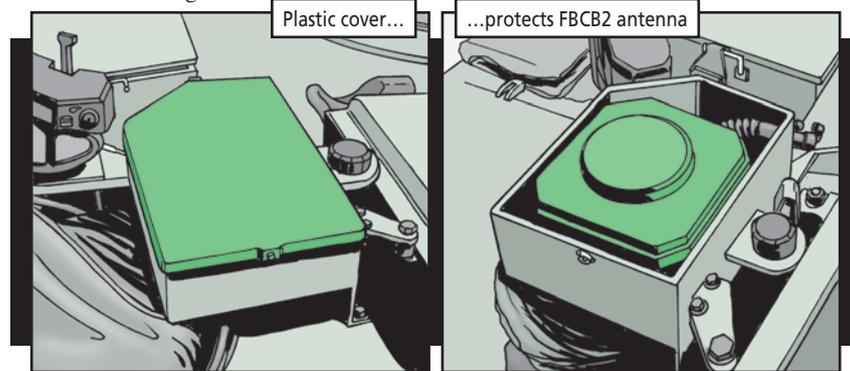
The antenna, NSN 5985-01-551-7316, is protected by a plastic cap. Too often, stray limbs and brush will break or knock off the cap, leaving the antenna unprotected. Since it's located on top of the tank, you might not notice until the antenna is damaged.

Take a quick look at the antenna before, during and after operations. If the cap is missing, replace it with NSN 5340-01-541-0758.
