Is Your Sling OK?

If you have the unit maintenance aerial recovery kit (UMARK), there could be a manufacturing defect in the slings, NSN 3940-01-538-5218, P/N 94H520-2.

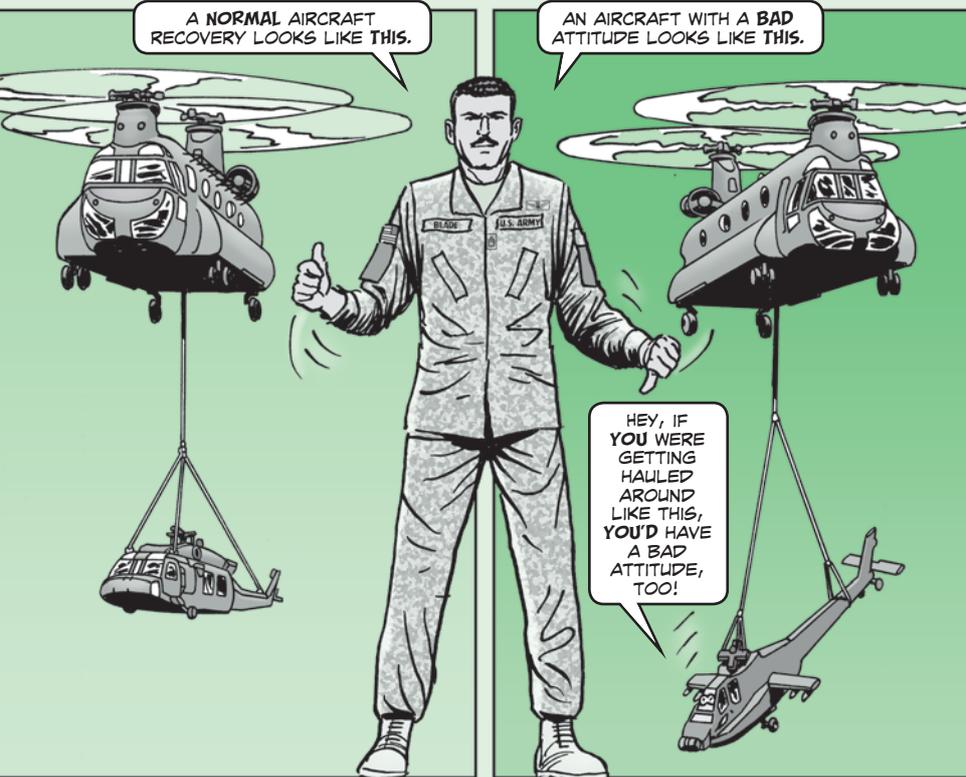
A NORMAL AIRCRAFT RECOVERY LOOKS LIKE THIS.

AN AIRCRAFT WITH A BAD ATTITUDE LOOKS LIKE THIS.

HEY, IF YOU WERE GETTING HAULED AROUND LIKE THIS, YOU'D HAVE A BAD ATTITUDE, TOO!

MAKE SURE YOU GET RID OF BAD SLINGS OR YOU'LL HAVE A BAD ATTITUDE.

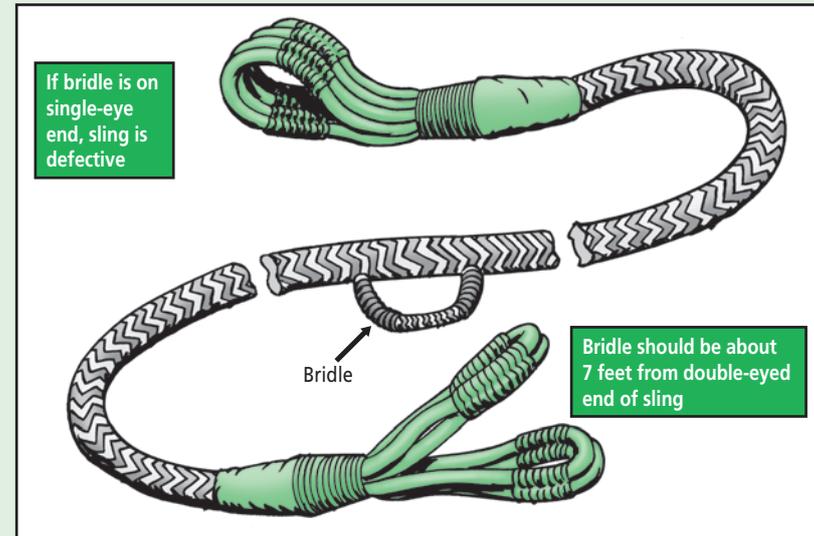
The problem with the sling is that the bridle was placed at the wrong end of the sling by the manufacturer. The sling has two distinct ends. On the "single-eyed" end, you have one eyelet. On the "double-eyed" end, you have two eyelets. The bridle of a correctly manufactured sling should be approximately seven feet from the double-eyed end. If the bridle is in **any other** location on the sling, it is defective.

When rigging an aircraft for recovery, the double-eye end of the sling is **ALWAYS** placed on the side of/pointing to the aircraft being recovered. If a defective sling is used, it will cause a severe nose down attitude of the aircraft being recovered and can cause further damage to the aircraft when it is set down upon completion of the recovery.

All units that have a UMARK kit need to identify, inspect, and purge all defective slings from their kits **now!**

If you have a defective sling, check out General Aviation Safety Action Message (GEN-11-ASAM-01) for inspection criteria and how to get a replacement sling.
