# CUT THE HOSE RUB

FIELD MECHANICS, THE HEATING,  
VENTILATION AND AIR CONDITIONING  
(HVAC) HOSES ROUTED BEHIND THE  
COMMANDER'S SEAT CAN END UP  
WITH A RAW DEAL.

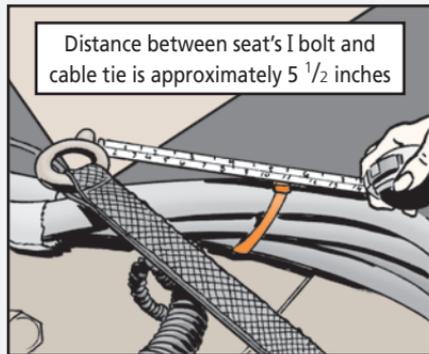
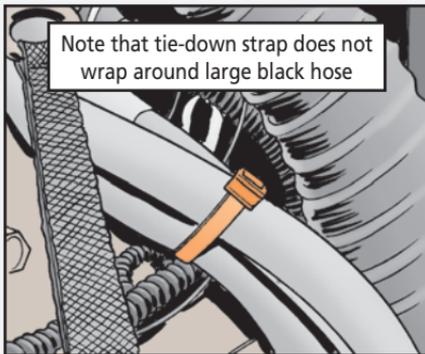
Distance between seat's I bolt and  
cable tie is approximately 5 1/2 inches

Note that tie-down strap does not  
wrap around large black hose

Get real close and eyeball the hoses for any wear marks. These hoses rub against the seat. Too much wear means a hole with coolant leaking out. Without coolant, there's no air conditioning. Talk about hot tempers in Southwest Asia!

See any rubs? Use a 6-in tie-down strap, NSN 5975-00-984-6582, to hold the HVAC hoses in place away from the seat. Place the strap on the hoses about six inches away from the I-bolt that's mounted on the back of the seat.
