M4/M4A1
Carbine...

DEFECTIVE ENHANCED SLIDING BUTTSTOCKS

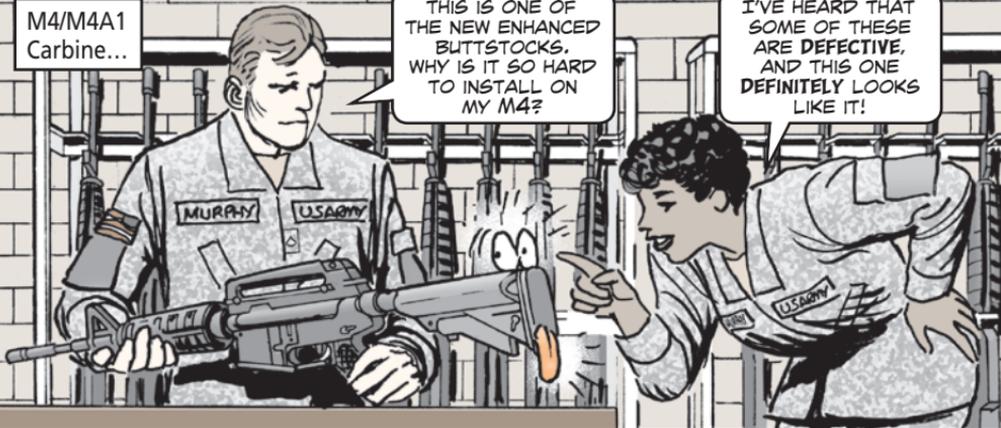
THIS IS ONE OF
THE NEW ENHANCED
BUTTSTOCKS.
WHY IS IT SO HARD
TO INSTALL ON
MY M4?

I'VE HEARD THAT
SOME OF THESE
ARE DEFECTIVE,
AND THIS ONE
DEFINITELY LOOKS
LIKE IT!

Some of the new enhanced sliding buttstocks, NSN 1005-01-544-9825, for the M4/M4A1 carbines are defective.

It's easy to spot the bad buttstocks. They are difficult to install on the M4 or fail to move smoothly or lock in place when installed. (**Note: These are not the standard M4 buttstocks.**)

If your enhanced sliding buttstock doesn't exhibit these problems, you're good to go. But if you've got a bad buttstock, submit a product quality deficiency report (PQDR). Use the link below.

TO SUBMIT A
PQDR, GO TO:
[http://www.
nslcptsmh.csd.
dlsa.mil/](http://www.nslcptsmh.csd.dlsa.mil/)

- Select Web PQDR under "Web Based Applications" at the upper left-hand side of the page.
- Select EZPQDR under "Important Links."
- Select the EZPQDR link under the Army EZPQDR paragraph.
- Select Accept on the "DOD Warning and Consent Banner" page.
- Fill in all mandatory fields ("m" indicates a mandatory field). Be sure to include the document number, contract number and cage code 58VQ8. This information is critical for accurate processing of the PQDR.
- Select ARMY (TACOM ROCK Island)-W91A52 under "2. Screening Point" on the EZPQDR
