Loader's Tray Losing Its Appeal

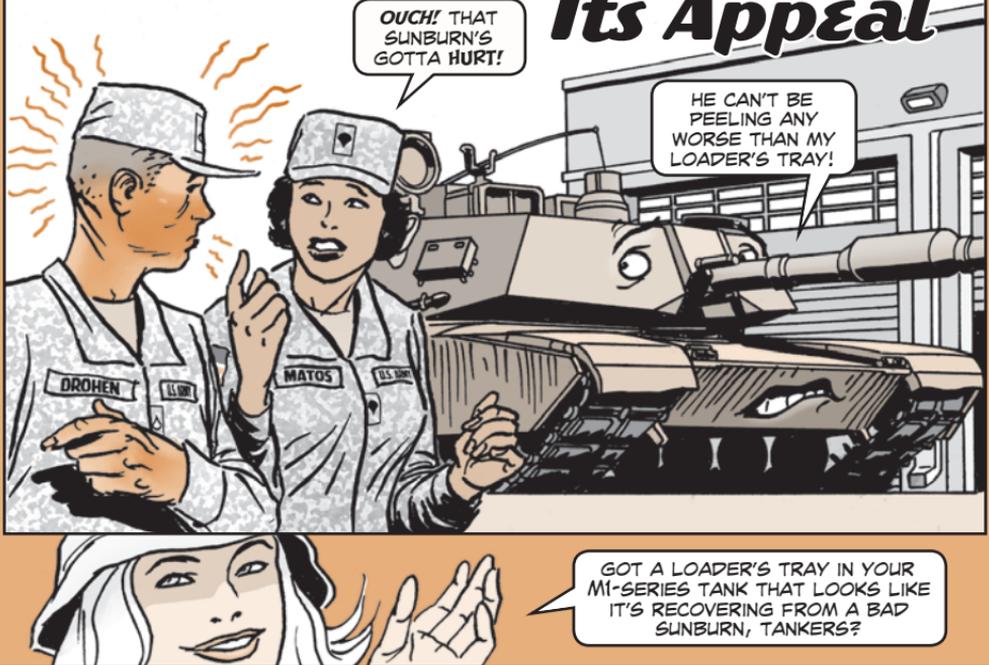
If your loader's tray is peeling, you've probably got a "3rd generation" tray, NSN 1015-01-537-0697 (PN 13010524). Those trays had a Teflon® coating added for extra protection, but they haven't lived up to expectations.

So if your tray is peeling, stop using it now! The peeled coating can get lodged in the chamber or breech and cause problems with firing the main gun.

Get the tray replaced with a new "4th generation" tray, NSN 1015-01-590-9661 (PN 13010524-1). The Teflon® coating on these trays has been replaced with a dry film lube phosphate coating that won't peel.

The new tray will appear in an upcoming revision to the M1A1 and M1A2 SEP parts manuals. Until then, grab your stubby pencils and add the new NSN as Item 73 in Fig 101 of TM 9-2350-264-24P-2 and Item 72 in Fig 64 of TM 9-2350-388-24P-2.
