A LITTLE LUBE'LL DO IT

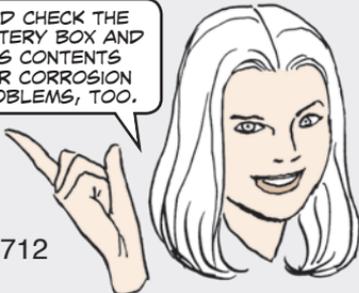
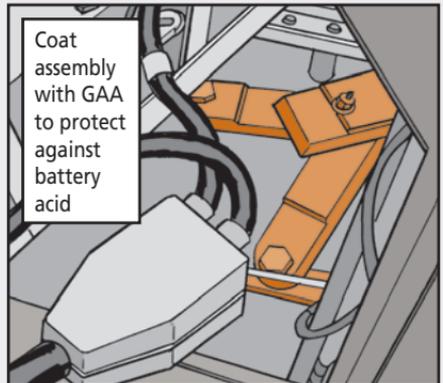
The assembly is to the side and below the battery box, so any battery leakage usually ends up on it, too. If it's not lubed regularly, the resulting corrosion makes the rods brittle. Eventually, they break.

Coat
assembly with GAA
to protect
against battery
acid

So, before you lube the steering linkage bell crank assembly quarterly with GAA, carefully wipe off any corrosion you find with a rag. If the corrosion is heavy, use a solution of water and baking soda. Wear rubber gloves and safety glasses to protect your hands and eyes.

Next, put a light coat of GAA on the outside of the assembly, then use your grease gun to lube normally. The GAA helps protect the assembly from battery corrosion until it's time to lube again.
