New Feed Tray Cover Causes Glitch

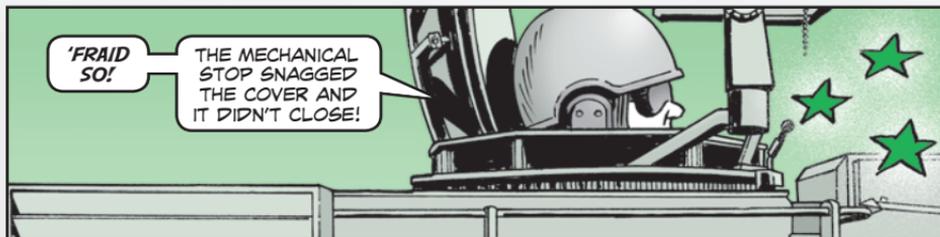
OUCH!

WAS THAT MY
M240'S FEED
TRAY COVER?

CRUNCH

The introduction of a new style feed tray cover for the M240 machine gun doesn't work well with the current mechanical stop.

The mechanical stop, NSN 5340-01-482-8376, is designed to automatically close the old feed tray cover. But the stop can bind or break the integrated rail of the new feed tray cover, NSN 1005-01-432-9538.

A new mechanical stop, PN 12988436-1, is being designed to work with both the old and new feed tray cover. PS will let you know when it's available in the supply system.

Until then, be aware of the potential snagging problem and always follow the instructions for loading and unloading the M240 machine gun. You'll find the procedures starting on Page 2-349 of TM 9-2350-264-10 (Mar 03, w/Ch 6, Jun 09) and WP 0209 of TM 9-2350-388-10 (Feb 09). Keep the cover closed as much as possible.
