PM That Works

Module Bolt Replacement

Air Dryer Filter Update

Access Cover Reminder

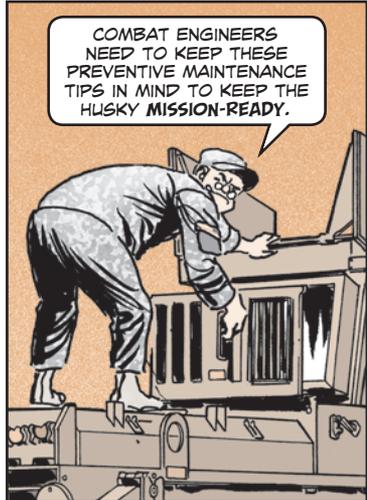
Some frangible bolts in the vehicle's front and rear wheel modules are designed to break during IED or land mine explosions.

Some well-meaning, but misguided, mechanics are replacing the bolts with stronger Grade 8 bolts that reduce Soldier protection. Plain and simple, these frangible bolts were designed for crewmember survivability, not maintenance efficiency.

USE THE RIGHT FRANGIBLE BOLT THAT COMES WITH NSN 5305-01-554-8238.

The correct bolt comes with NSN 5305-01-554-8238. Use it! Also, use the nylon-locknut, NSN 5310-01-554-4749, that holds each bolt in place.
