PIN DOWN BAD FIRING PINS

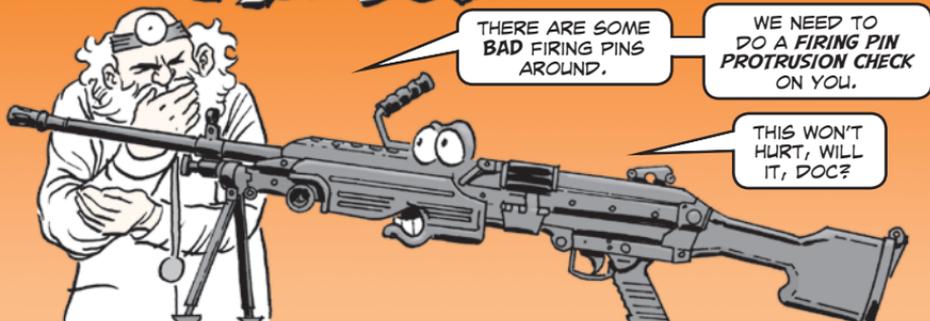
A small number of bad M249 machine gun firing pins have gotten into the field. The bad pins may not protrude completely through the bolt or may protrude too far, causing probable misfires.

Look for CAGE 19204 and a date on or before December, 2011

Armorsmen need to check all their replacement firing pins for a CAGE code of 19204 on their packages. If these pins are dated on or before December 2011, they should be demilled.

But any time you replace an M249 firing pin, do the protrusion check on Page 3-54 of TM 9-1005-201-23&P (Jun 02). That way you know you're installing a good firing pin.

Do protrusion check when replacing firing pin

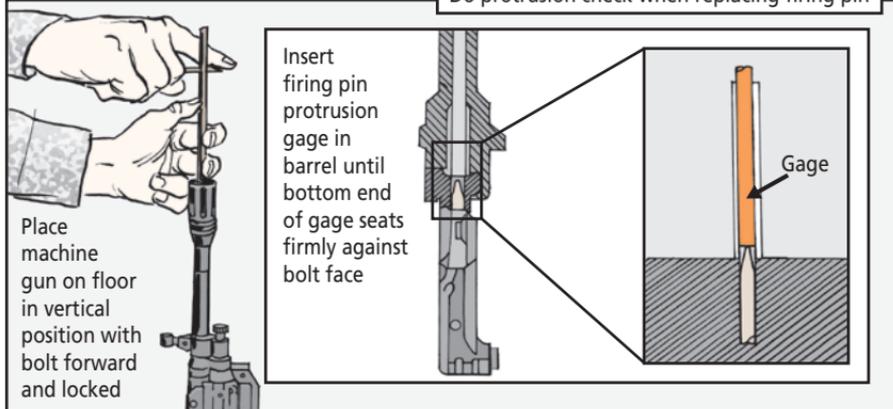
1005011285705

1005 01-128-5705

CAGE 19204-PIN:9348395

PIN: FIRING

MOP: M31 - 8/10 1 EA
