Spring Pin's NSN Changes

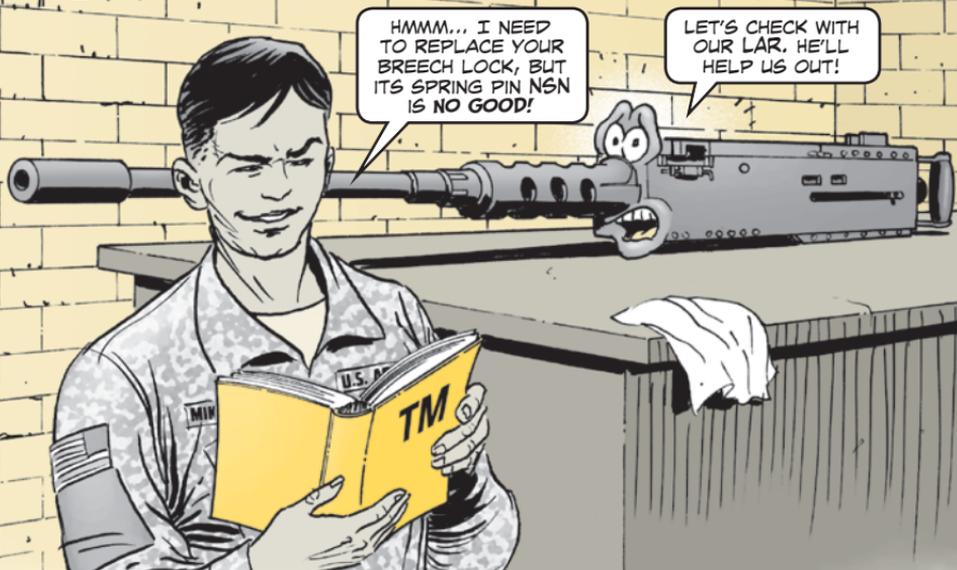
When you replace the breech lock, you're also supposed to replace the spring pin, NSN 5315-01-541-7233. It's shown as Item 18 of Fig 1 in TM 9-1005-347-23&P. Unfortunately, the spring pin's NSN is no longer good.

We checked with TACOM and they said you must now order the spring pin with NSN 5315-00-051-8637. Keep in mind that NSN brings 100 pins.

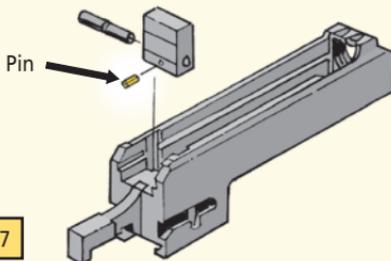
Order spring pin with NSN 5315-00-051-8637
