PMCS Is Path to Good Firing

Machine Gun Mounts...

What is M66 Cover NSN?

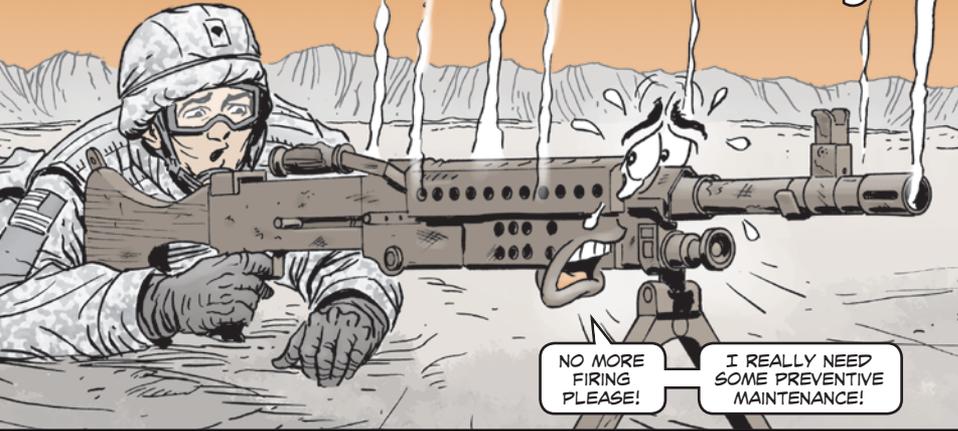
NO MORE FIRING PLEASE!

I REALLY NEED SOME PREVENTIVE MAINTENANCE!

Recently there have been several instances on firing ranges of M240 machine guns (particularly the M240L) malfunctioning.

Investigation showed these causes:

- dirty weapons
- rusty barrels
- lack of lubrication
- firing again and again without switching barrels

Four simple letters could have prevented most of these problems: **PMCS**.

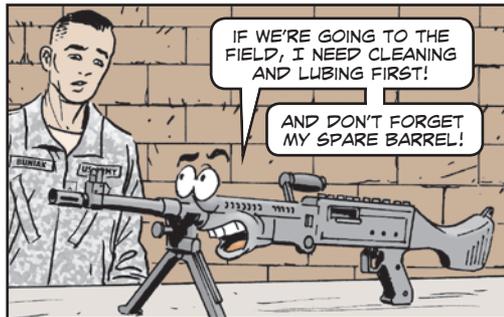
IF WE'RE GOING TO THE FIELD, I NEED CLEANING AND LUBING FIRST!

AND DON'T FORGET MY SPARE BARREL!

BEFORE PMCS: Clean and lube the M240 like TM 9-1005-313-10 says. Do this even if the weapon is newly issued. Look for damaged or missing parts. Make sure you have all the basic issue items (BII) and components of end item (COEI) you'll need in the field, particularly the spare barrel, the -10, lubricants and cleaning materials.

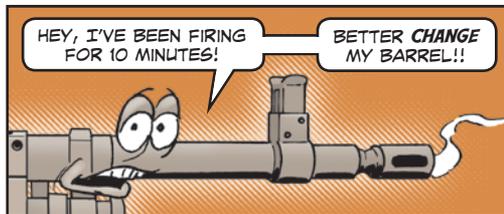
HEY, I'VE BEEN FIRING FOR 10 MINUTES!

BETTER CHANGE MY BARREL!!

DURING PMCS: Rotate the barrels every 10 minutes during sustained fire and every 2 minutes during rapid fire. If the M240 starts firing sluggishly, stop and clean it.

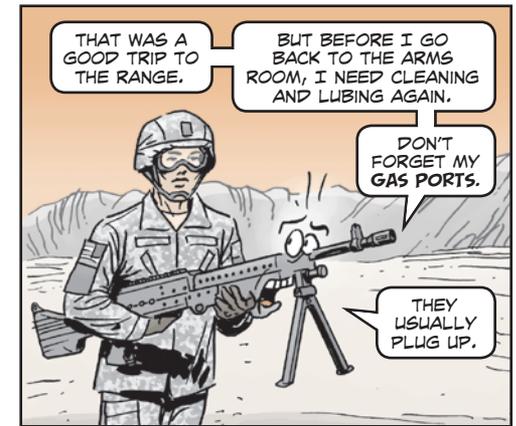
THAT WAS A GOOD TRIP TO THE RANGE.

BUT BEFORE I GO BACK TO THE ARMS ROOM, I NEED CLEANING AND LUBING AGAIN.

DON'T FORGET MY GAS PORTS.

THEY USUALLY PLUG UP.

AFTER PMCS: Clean and lube the M240 before it goes in the arms room for storage. Pay special attention to the gas regulator and gas ports, which tend to gunk up with carbon.

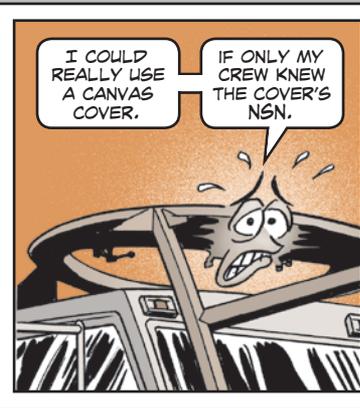
I COULD REALLY USE A CANVAS COVER.

IF ONLY MY CREW KNEW THE COVER'S NSN.

Dear Chief P.R.,
Certainly. Order an M66 cover with NSN 1005-00-707-0725. It costs around \$275. You can also now order a plastic "shower cap" cover with NSN 1005-01-610-9108 for around \$300.
Half-Mast

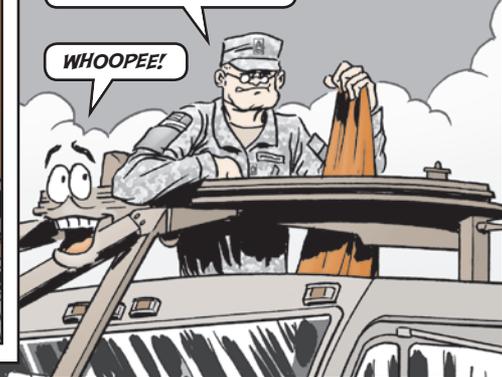
Dear Half-Mast,
We are trying to order a canvas cover for our M66 ring mount, but can't find the NSN for one. Can you help?
CW2 P.R.
