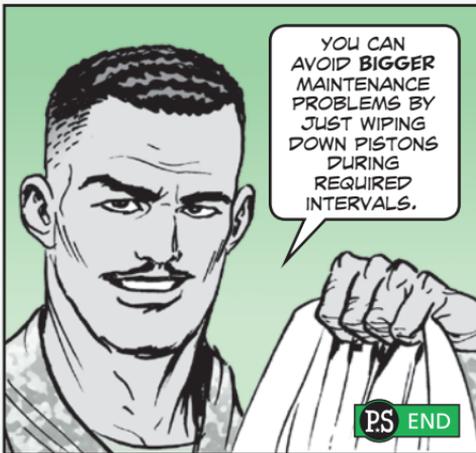
Remember though, when you inspect the hydraulic deck pistons, some seepage is allowed, like it says in WP 0691 00 of TM 1-1520-237-23-4. Follow the leakage inspection criteria for the M-model like it says in TM 1-1520-280-23&P.

If the piston surfaces aren't cleaned regularly, dirt and grime build up and eat away the seals, causing leaks and blown seals. If leaks happen and seals blow, cleaning is no longer an option. You'll have to remove other parts of the aircraft to repair more damage from blown seals.

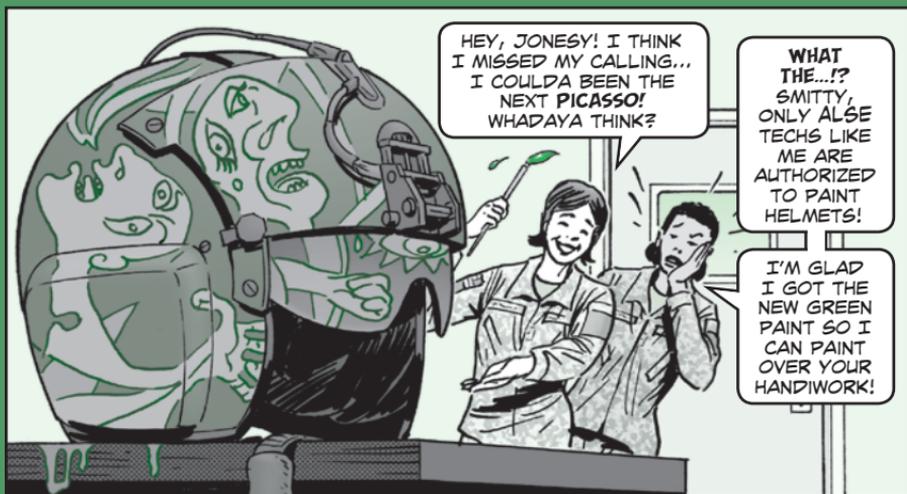
**ELSE** techs, Page 41 of 693 (Aug 10) told you about the color change to foliage green for the aircrew integrated helmet system (AIHS), HGU-56/P helmet.

Good news! There's now a new foliage green paint, NSN 8010-01-576-8919, available for spot painting the helmet.

Make a note until all the details about the new paint are added in the next update to TM 1-1680-377-13&P-1. For all helmet painting information, check out WP 0058 00 in TM 1-1680-377-13&P.
