Watch Out For Moving SATS

Mechanics, if your standard aircraft towing system (SATS), NSN 1740-01-575-5662, suddenly moves while you're doing PMCS, a faulty, shorted diode is most likely the culprit.

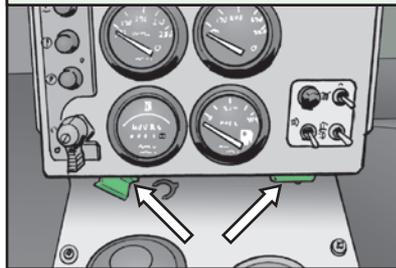
1. Loosen the two clamps on the bottom of the dash panel.

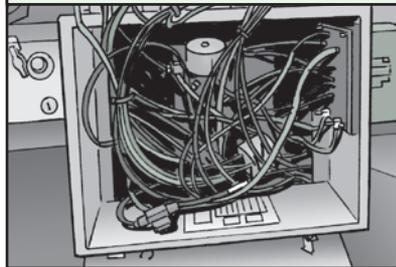
2. Open the panel to expose the dash wiring harness.

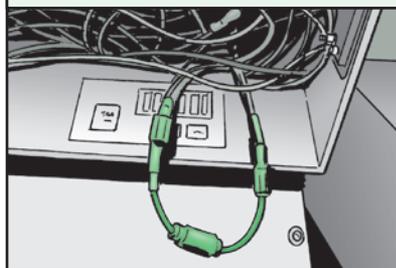
4. Locate the diode assembly on wires 66 and 109.

5. Remove the diode assembly at both 1/4-in terminals.
