# FIX THAT SNEAKY COUPLING LEAK

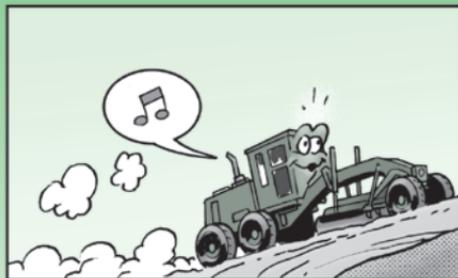
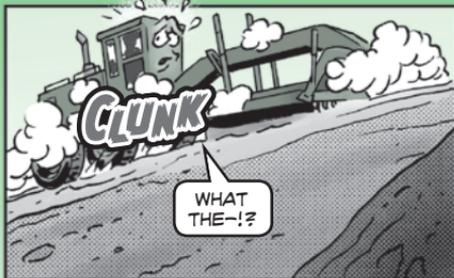
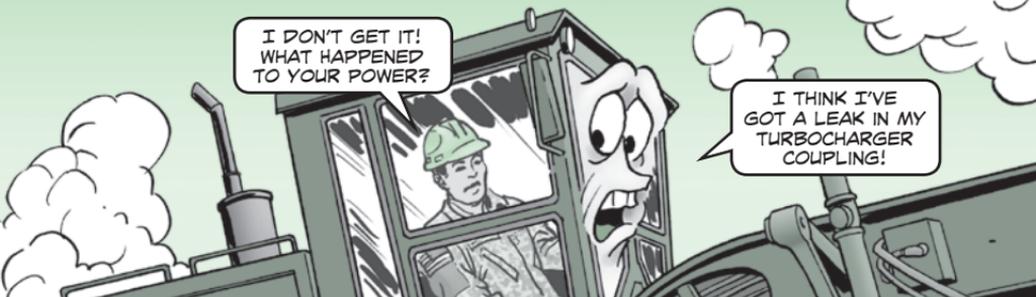
If the coupling is loose, misaligned, or its seal rings are missing or damaged, your grader will lose some turbo boost and may seem sluggish.

So eyeball the coupling for a bad connection to the muffler. Check for signs of leakage, such as carbon stains. Then look at the seal ring to see if it's missing, cracked, split or torn.

If you find any of these problems, tell your mechanic. He'll loosen the muffler-to-turbo connection and align the muffler with the coupling.

While he does that, he can check out the seal rings. If they're damaged, he'll replace them, including the packing and gaskets.

Once everything's OK, he'll tighten the connection and you're back in business.
