M1074A1,
M1075A1 PLS...

GET REPLACEMENT FOR SHIFT CABLE BOOT

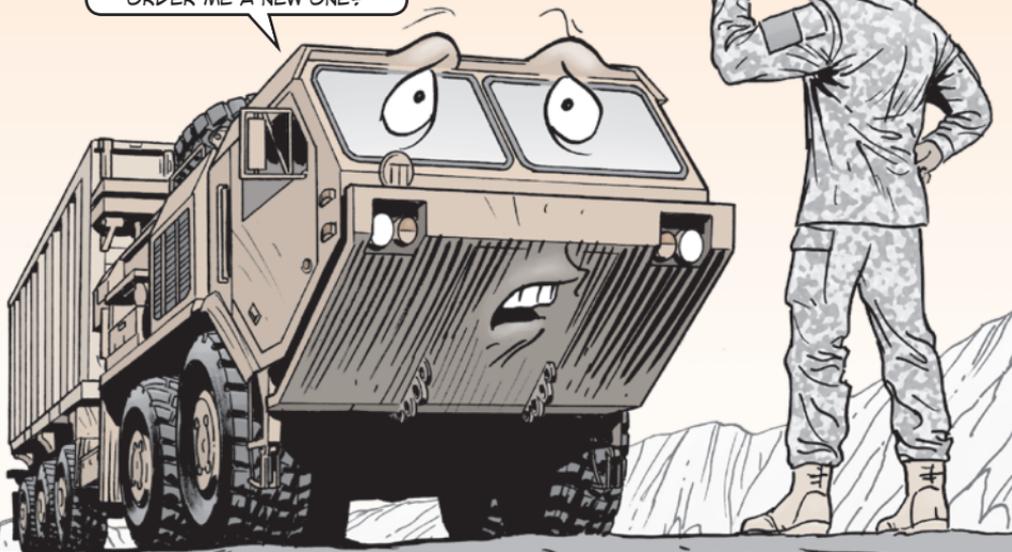
THE BOOT ON MY
TRANSFER CASE SHIFT CABLE
HAS SPLIT OPEN. CAN YOU
ORDER ME A NEW ONE?

Mechanics, the rubber boot, NSN 2530-01-192-4315, that covers the transfer case shift cable on the M1074A1 and M1075A1 PLS is deteriorating before it should.

As it weakens, the boot splits open between its folds. That allows dirt, debris and water to jam and corrode the shift cable.

If your truck is under warranty, go through the warranty process to get a replacement boot.

Out of warranty? No problem.

Just send an email to Oshkosh at:

In the email, include a good shipping address. They'll send you a free replacement boot along with installation instructions.
