IT'S ALL ABOUT IMAGE

Field maintenance technicians, if you work on AN/PVS-14 monocular night vision devices (NVDs), AN/AVS-6 aviator's night vision imaging systems or AN/PVS-7 night vision goggles, listen carefully.

When you inspect and test the image intensifier tube, some of you are reaching the wrong conclusion about the condition of the tube. In other words, you're finding problems that don't exist and then turning in a perfectly good tube for disposal.

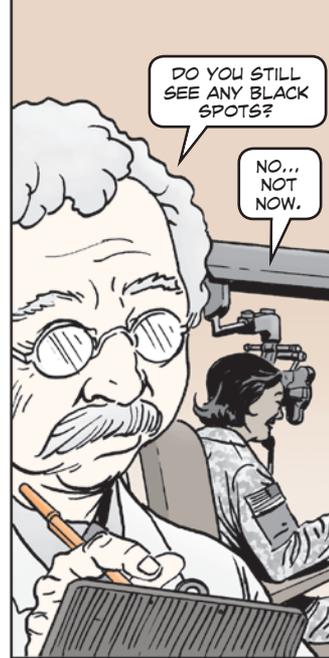
DO YOU STILL SEE ANY BLACK SPOTS?

NO... NOT NOW.

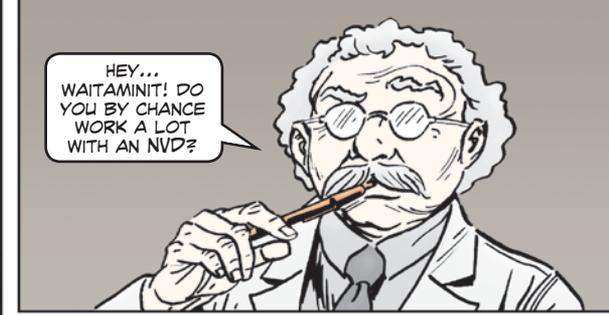
HEY... WAITAMINIT! DO YOU BY CHANCE WORK A LOT WITH AN NVD?

I THINK I KNOW WHAT YOUR PROBLEM IS!

For example, the size and location of black spots often mislead technicians into thinking a tube is damaged. Actually, black spots are OK if they pass the black spot check in your TM.

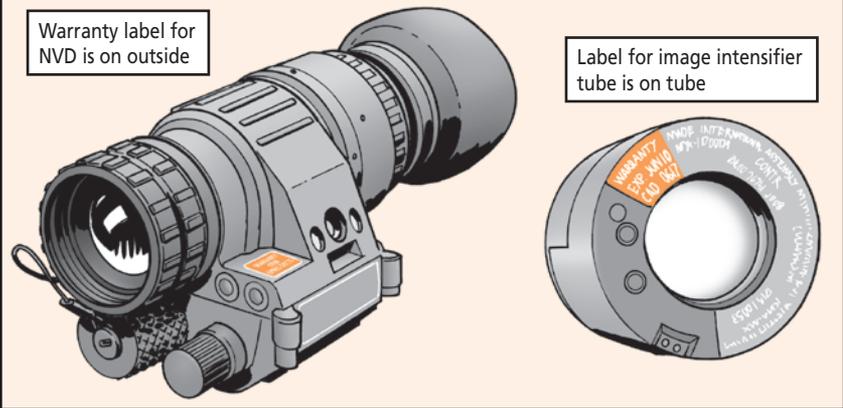
Warranty label for NVD is on outside

Label for image intensifier tube is on tube

Also check the warranty labels to make sure the warranties haven't expired. There are two warranty labels. The label for the NVD is on its outside. The label for the image intensifier tube is on the tube itself. You have to remove the eyepiece to get to the tube.
