# CHECK MORTAR TUBES FOR STRESS CRACKS

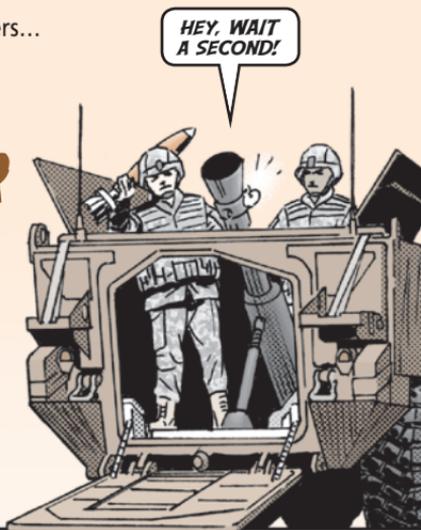
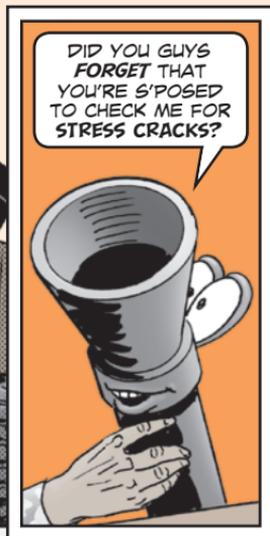
Crewmen, testing has shown that some 120mm mortar tubes on mortar carrier (MCV) Strykers are developing stress corrosion cracks. The cracks are appearing on the portion of the barrel under greatest pressure: between 46 and 51 inches from the muzzle end of the mortar. Those cracks could cause the mortar tube to rupture, resulting in severe injury or even death!

No mortar tube failures or injuries have been reported to date. But all 120mm mortar tubes in MCV Stryker and double "V" hull MCVVs need to be visually inspected immediately. Magnetic particle inspection of mortars has already started.

Do not fire any mortar tubes that have stress cracks. Report them to your repair team right away. Make sure mortar tubes are clean at all times because environmental factors, such as the presence of corrosive chemicals during firing, will cause stress corrosion cracks.
