EASY DOES IT ON TAILGATE

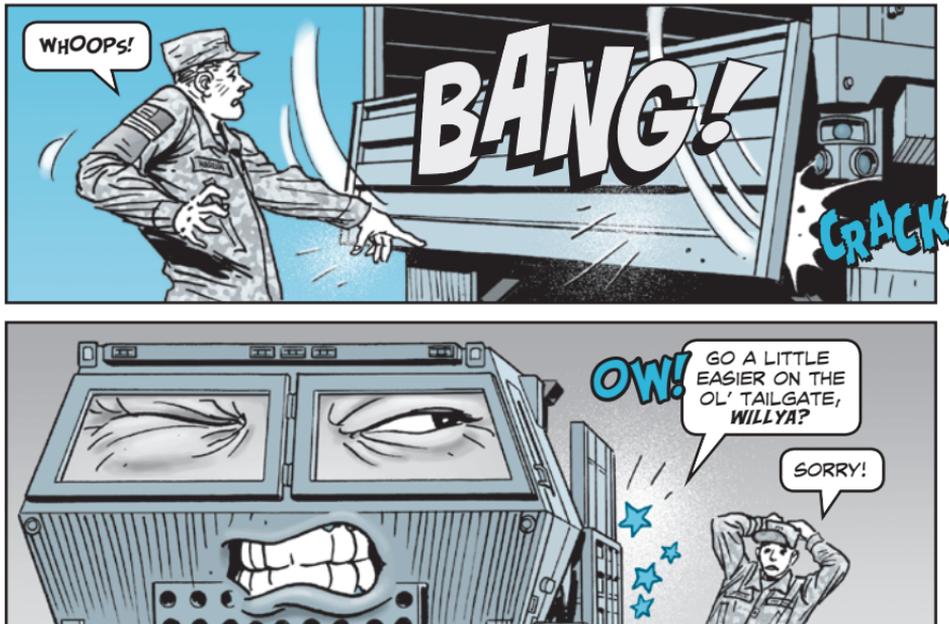
Drivers, slow and easy is the way to go when lowering the tailgate on your M1083 FMTV. Let it drop and you'll probably be looking at damage.

Sure, the tailgate has two rubber bumpers, NSN 5340-01-058-7384, on each end. And they're designed to absorb the shock of lowering the tailgate.

So whenever you lower the tailgate, easy does it. Lowering the tailgate gently will keep the bumpers in operation and the damage at bay.

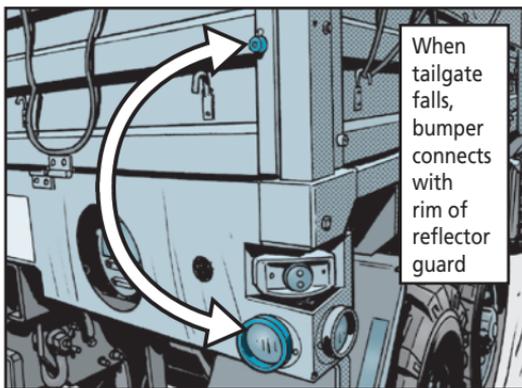
Unfortunately, both bumpers line up perfectly with the top edge of the metal guards protecting the rear reflectors. If your tailgate comes crashing down, the bumpers hit the edge of the guards. That can split the bumpers, causing them to fall off. The next time you open the tailgate, there's no cushion and both the reflector guard and the tailgate get damaged when they connect.
