VIGILANCE KEEPS CORROSION AT BAY

M109A6 PALADINS WITH REPAIRED GUN TUBES NEED EXTRA VIGILANCE TO MAKE SURE THEIR GUN TUBES ARE GOOD TO GO.

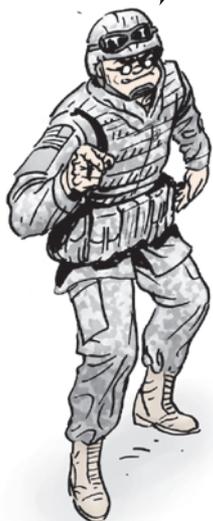
FIRST, CHECK THE SERIAL NUMBER ON YOUR PALADIN'S GUN TUBE.

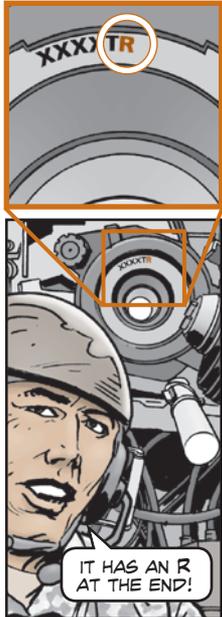
IT HAS AN R AT THE END!

THAT R AT THE END MEANS IT'S A REPAIRED TUBE...

... AND YOU'LL NEED TO FOLLOW SOME SPECIAL CLEANING, INSPECTING, AND LUBING INSTRUCTIONS DAILY AFTER FIRING.

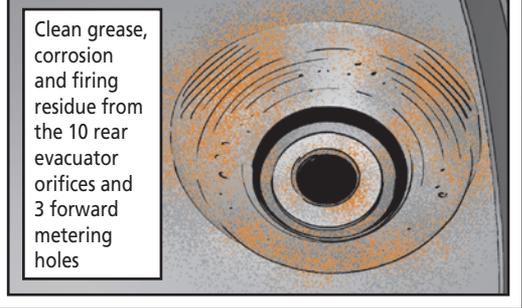
1. With the bore evacuator disassembled, give the 10 rear evacuator orifices and 3 forward metering holes a good cleaning with CLP, NSN 9150-01-054-6453. Make sure you get rid of all grease, carbon and corrosion so that you can clearly see the gun tube.

Clean grease, corrosion and firing residue from the 10 rear evacuator orifices and 3 forward metering holes

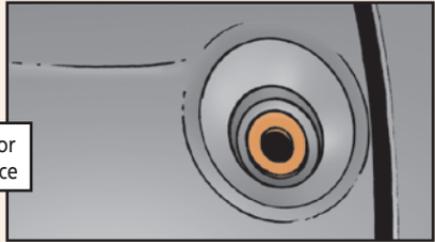
2. Eyeball all 13 of the holes closely. If any of the bushings around the holes show signs of pitting or other corrosion damage, the service life of the tube is reduced. Tell your mechanic.
3. Check each of the 10 rear evacuator orifice bushings for clearance. The 3 forward metering holes do not have to be inspected.

Inspect the 10 rear evacuator orifice bushings for clearance

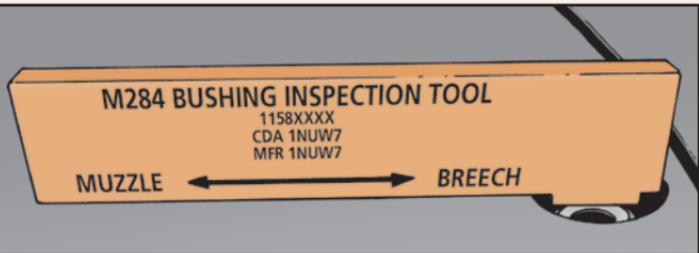
Two M284 bushing inspection tools are included with every repaired gun tube. Place one of the tools on the gun tube following the instructions that are printed on the tool. Make sure the measurement end of the tool hangs over the hole. There should be a gap between the bottom of the tool and the top of the bushing. If the tool touches any of the 10 bushings, tell your mechanic.

Two M248 bushing inspection tools included with every repaired gun tube
