CHECK THOSE RETAINING PINS

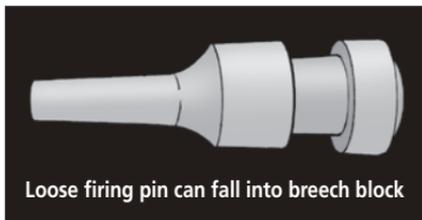
We're seeing a lot of M119A2 howitzers come into our shop with loose firing pins caused by worn-out retaining pins.

A worn retaining pin, NSN 5315-01-342-0442 for the A2 and NSN 5315-01-616-3457 for the A3, can allow the firing pin to slip out of position and fall into the breech block.

When that happens, it's tough to get the firing pin back into the right position. Also, the firing mechanism can't be turned or removed as long as the firing pin is out of position.

Loose firing pin can fall into breech block

It's a good idea to perform the firing pin protrusion test every time after firing. Also, we think it's a good idea to replace the retaining pin during annual service.

Replace retaining pin during annual services

Editor's note: Thanks for the great information. Crewmen, you'll find instructions for the firing pin protrusion test in WP 0043 10 of TM 9-1015-252-10 (Sep 10) for the A2 and WP 100 12 of TM 9-1015-260-10 (Oct 14) for the A3.
