HOSES GETTING RUBBED THE WRONG WAY?

OPERATORS, THE HYDRAULIC HOSES NEXT TO BOTH OF THE 120M GRADER'S FRONT WHEEL DRIVE ASSEMBLIES ARE GETTING A RAW DEAL.

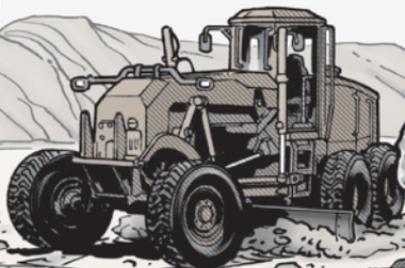
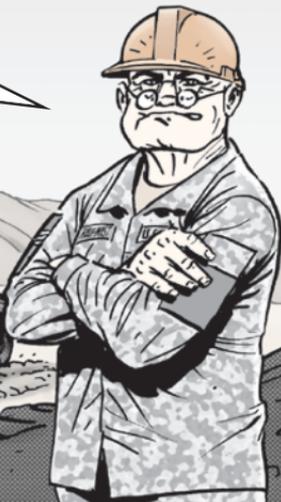
The hoses rub against each other and against the tire and wheel assemblies during operation. Eventually, all that rubbing wears holes in the hoses. Leaks lower the hydraulic pressure till there's not enough left to operate the grader.

So get down on your hands and knees to eyeball those hoses for indications of wear. If you find problems, particularly hoses worn enough to expose the metal braiding, contact your local Caterpillar dealer. They'll inspect the hoses, replace any that are badly damaged and add a special hose wrap for additional protection. Inspection and repair is free of charge to your unit.

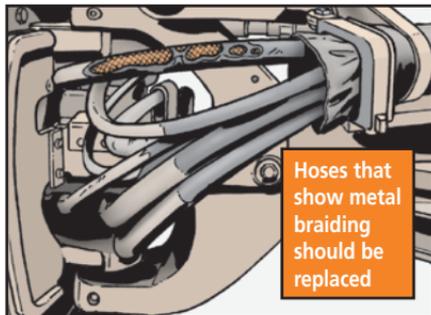
Hoses that show metal braiding should be replaced

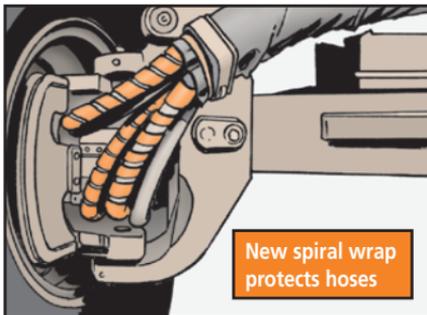
New spiral wrap protects hoses
