# Down On Your Luck?

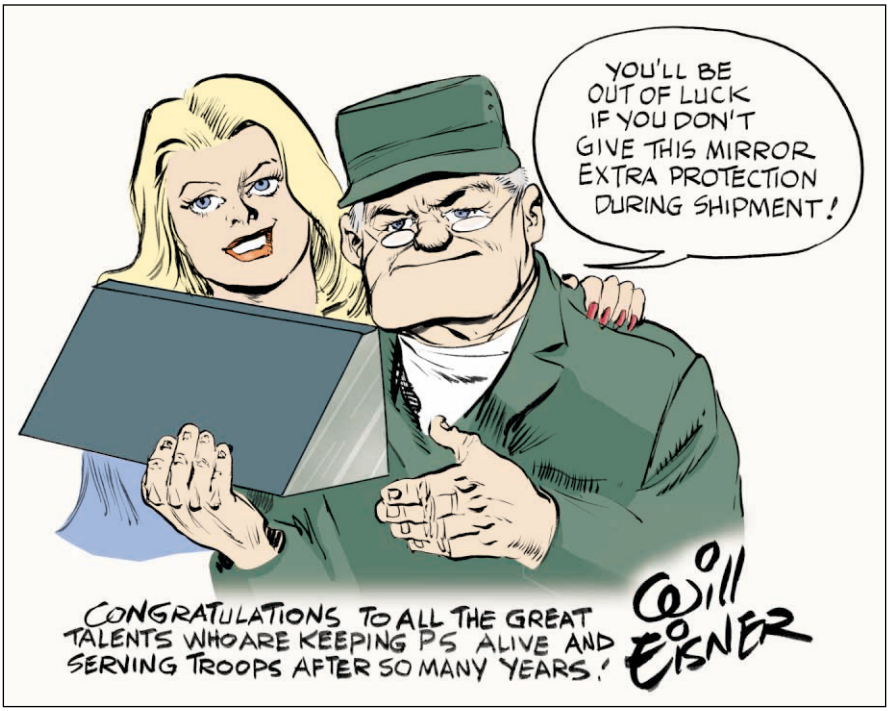
While it won't cause you 7 years of bad luck, damaging the head mirror on your tank's dual axis head assembly (DAHA), NSN 1240-01-362-1914, can cost your unit some extra bucks.

The problem comes when a damaged DAHA is sent in for repairs. Even when you send the assembly in its shipping container, NSN 8145-01-476-4131, loose pieces of metal, dust and loose desiccant can scratch the head mirror. The DAHA arrives even more damaged than when it was shipped.

Stop that extra damage by first wrapping the head mirror in lens paper, NSN 6640-00-436-5000, followed by a layer of cardboard. Hold the coverings in place with masking tape.

Add a small bag of desiccant, NSN 6850-00-264-6571, to the shipping container to protect against moisture and the DAHA should arrive the same way it was shipped.
