Alternative SHOCK for Armor

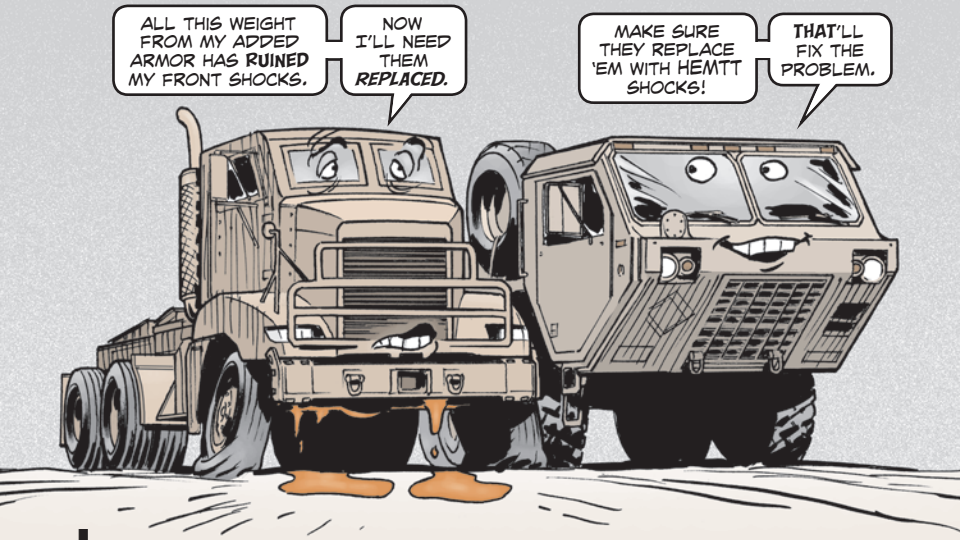
If your unit has up-armored M915A3 trucks, you may have already noticed that the front shocks, NSN 2510-01-479-1515, don't handle the added weight of the armor too well.

Some Soldiers have found busted shocks, leaking fluid and worn tires that need replacing too soon! But you can stop this.

One unit at Ft Campbell discovered that installing HEMTT shocks, NSN 2510-01-132-4983, fixed this problem. This NSN brings the upper and lower bushings and the shock. It fits right on, too, so no mods are needed. Plus, TACOM LCMC approves this.
