# 40 MPH Speed

Unless your M939-series 5-ton trucks have had MWO 9-2320-272-55-1 applied, their highway speed limit is still 40 mph.

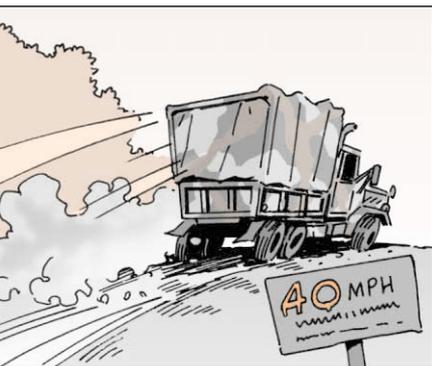
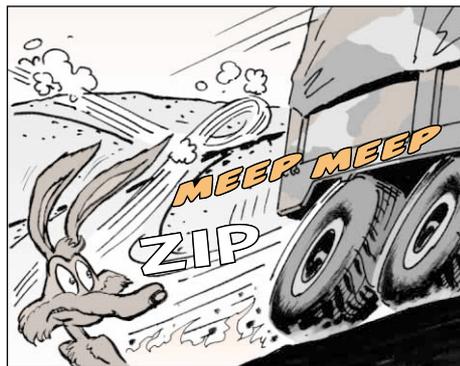
TACOM Safety-of-Use Message (SOU) 00-018 (Jul 00), *Resumption of Safe Operating Speeds for M939 Family of Vehicles Following Retrofit of Anti-lock Braking System (ABS)*, authorizes you to resume normal operating speeds only after MWO 9-2320-272-55-1 is applied.

Application of ABS to your trucks rescinds the requirement for MWO 9-2320-272-20-7 and removes the brake proportioning valve installed during that modification. Never add MWO -20-7 to a truck that has been modified by MWO -55-1. It's not needed then.

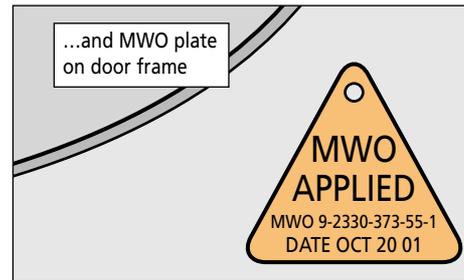
Trucks with the ABS MWO have a yellow triangular decal with black lettering "ABS" in the lower left corner of the windshield. 'Course, there'll be a regular MWO tag on the cab reinforcement just inside the driver's door, too.

MWO 9-2320-272-20-7, which still has not been applied to some vehicles in the fleet, installed a brake proportioning valve kit to prevent front-wheel lockup during heavy braking when driving on slick surfaces with little or no load on-board.

TACOM SOU 98-07 (Apr 98), *Safe Operating Speeds for M939 Series Trucks*, dropped speeds to 40 mph and outlined safe driver practices. It is still in effect until MWO -55-1 is installed.
