TAKE TIME TO TAPE APU

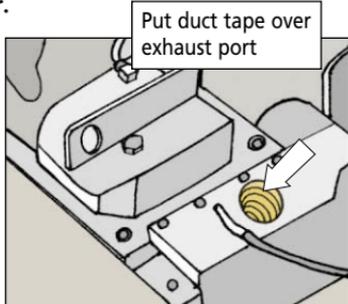
When the APU is removed, the exhaust port is left wide open. That lets water—from rain, condensation or any other source—inside the APU. The water seeps past the exhaust valves, enters the combustion chamber and rusts the piston to the side of the cylinder.

Most of this damage could be prevented if mechanics would seal the exhaust port with a piece of duct tape immediately after removing the APU. That keeps water out and damage to a minimum.

That little piece of duct tape sounds like a good investment! It's probably a good idea to further protect the APU by shrink wrapping it before shipment to the repair site.
