TIGHTEN DOWN THE ANTENNA

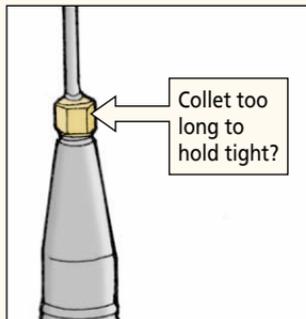
The mast element of the AS-3916/VRC antenna often comes loose from the base, because the collet, NSN 3460-01-435-8079, is too long to hold it tight.

The problem is the collet bottoms out before adequately clamping onto the element.

This can be solved by unscrewing the collet from the antenna base and filing off 1/16 of an inch from the collet bottom.

This lets the collet be tightened fully and stay tight like it should.
