COUNTERMEASURE SET UPGRADE

UH-OH! NO FILTER!

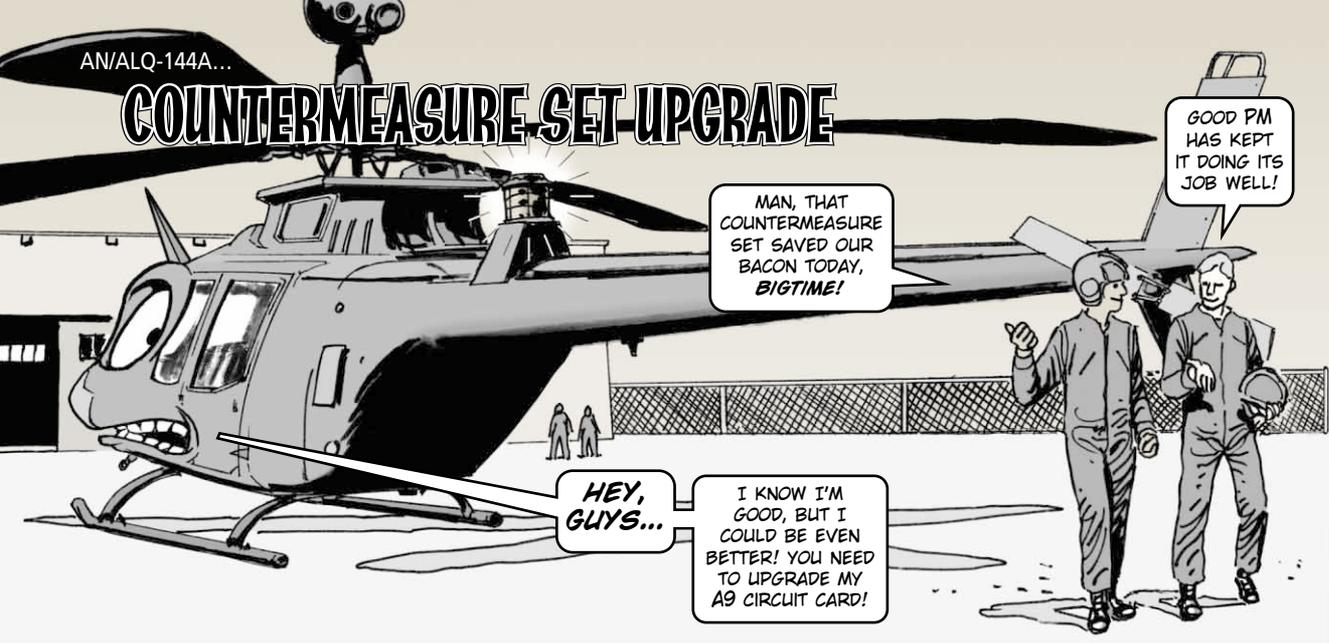
To determine if your countermeasure set needs an upgrade, check the A9 card for a red strip on the U4 chip and a red dot on the S1 thumb wheel switch.

IF U4 IS MISSING A WIDTH-WISE RED STRIP OR S1 IS MISSING A RED DOT ON THE SIDE, CONTACT CECOM'S CLIFF VERMONT AT DSN 992-2472, (732) 532-2472 OR E-MAIL cliff.vermont@mail1.monmouth.army.mil FOR UPGRADE DETAILS.

CECOM has an upgraded A9 circuit card, NSN 5998-01-464-2151, that'll keep your set humming.

HE'LL HELP YOU ACCOMPLISH THE A9 CIRCUIT CARD UPGRADE PROCESS.
