# BRUSH UP ON MINE BLADE REPAIRS

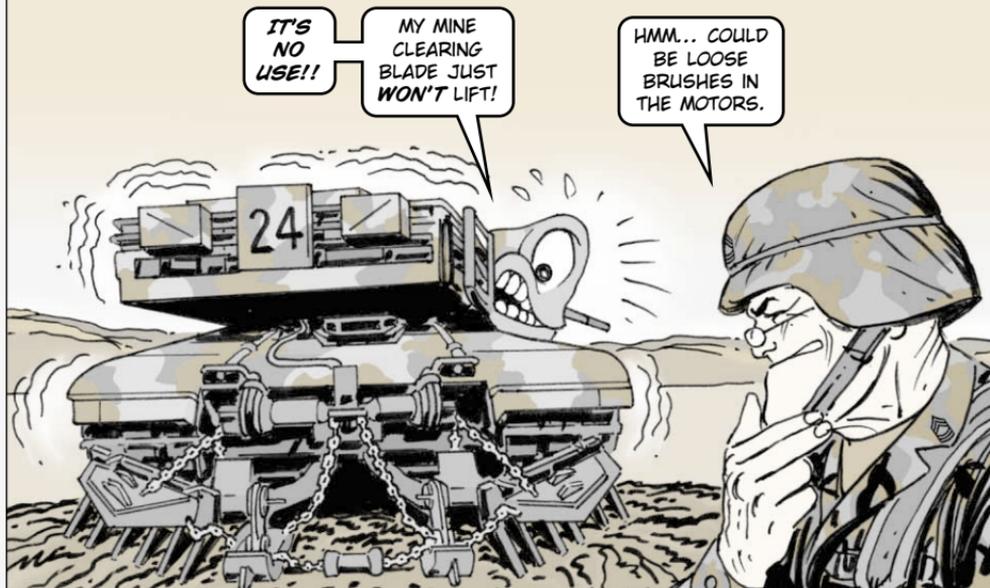
The mine clearing blade on an M1-series tank won't be clearing much of anything if the lifting mechanism, NSN 2590-01-277-0060, isn't working, mechanics.

The number-one lifting mechanism problem is loose electrical brushes in the motors. That's especially true if the operator does a lot of "combat drops" or changes the motors' direction without first letting the mine blade come to a complete stop. Reinstalling the brushes usually fixes the problem.

If not, the brushes may be burned out. Install new brushes, NSN 5977-01-412-0758. You'll need four brushes for each motor.

If one of the motors, NSN 6105-01-277-0295, still won't work, you may need to replace it. At around \$3,500, that's still a lot cheaper than ordering a new lifting mechanism.
