BROKEN BOLT A BUMMER

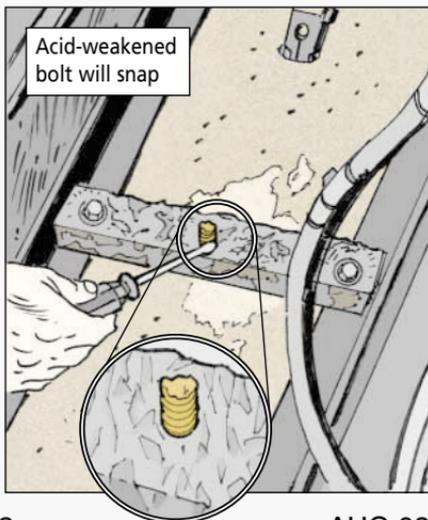
Unless the crew checks MLRS carrier batteries often, there's going to be a little overflow of battery acid from time to time, mechanics.

That acid drips down to the bottom of the battery box, coating the battery tie-down bolt, NSN 5306-00-933-1131. Then the bolt weakens and snaps when you try to remove the batteries.

Before installing a new bolt, try coating the new one with some primer coating, NSN 8010-00-515-2208, and lacquer, NSN 8010-00-166-1667. The primer coating and lacquer provide a protective coating that keeps acid from eating away at the tie-down bolt.
