Them's the Brakes!

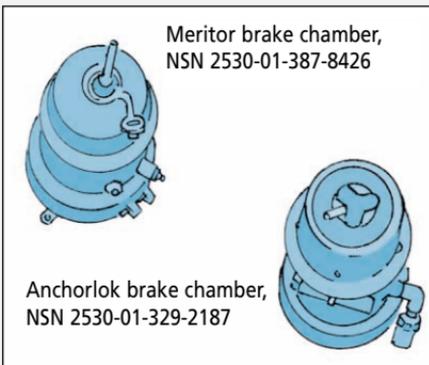
The original Anchorlok brake chamber, NSN 2530-01-329-2187, used in the M1000 is too big. It can hit the underside of the platform if the semitrailer is fully lowered. The brake chamber can even be dislodged, resulting in air loss great enough to lock up **all** the brakes on the semitrailer.

That leads to significant tire damage and, depending on road conditions, could result in your losing control of the vehicle.

To prevent this, a new Meritor brake chamber, NSN 2530-01-387-8426, was listed in Change 2 to the -24P TM. Unfortunately, some units without this change are continuing to order the old Anchorlok brake chamber.

So, right now, go check the brake chambers on your M1000. If you find any with Anchorlok printed on the top of the chamber, notify TACOM. You may even be eligible for a free-issue replacement of the brake chambers.
