HH-60L/UH-60A/L...

NO TAIL ROTOR HARDWARE MIX-UP THIS TIME!

# USE COLOR FOR BALANCE, TOO

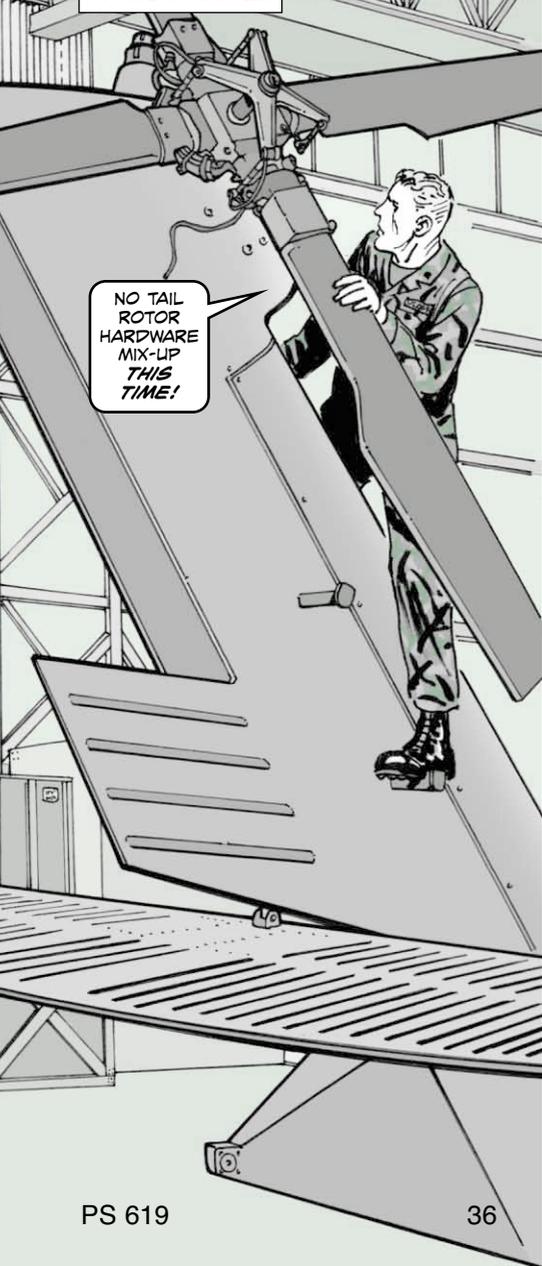
The instructions to make the tail rotor hardware display board do not allow for the rotation of the tail rotor which may happen while it is disassembled.

THE POTENTIAL FOR TAIL ROTOR ERROR BY *NOT* SHOWING THE COLORS COINCIDING WITH THE TOP, BOTTOM, AFT, AND FWD ON THE BOARD IS IMPORTANT.

If the tail rotor blades being removed are to be installed in the same gear box, and the color bands have worn off, use a grease pencil and put index marks on blades, retention plates, pitch control rods, and pitch beam so they are reinstalled in the same clockwise and inboard/outboard positions to minimize rebalancing of the tail rotor.

To maintain proper tail rotor balance, it's also important to mark the board with red, yellow, blue and black labels as shown on the retention plate. This will further reduce hardware mixup because if the rotor turns, it ensures the hardware will be installed in the same position from which it was removed.

It's also important that the pitch beam, inboard retention plate and outboard retention plate and each pitch control rod are marked with the correct color, too.
