YOU COULD BECOME THE NOWHERE MAN IF YOU DON'T HAVE THE LATEST SOFTWARE INSTALLED IN YOUR PRECISION LIGHT-WEIGHT GPS RECEIVER (PLGR) OR THE ENHANCED (EPLGR) MODEL.

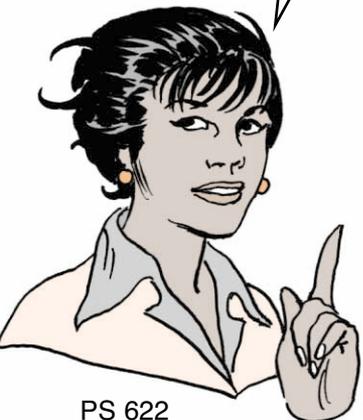
Old software could cause your PLGR/EPLGR to continually reset and the display to flash over and over. That would make your precision receiver not so precise!

Even if you haven't had these problems, check what software you're using. As you power up the PLGR/EPLGR, look for the 10-digit number. It will be on the third line of the first display. If you're already powered up, you can find the number on a status page by using the MENU key.

If you spot numbers 613-9854-005 or 613-9868-008, you're up-to-date and good-to-go. (PLGR+96 software version 613-9868-008 is the preferred operating system if the hardware will support it.)

Any other numbers mean you need new software. See your CECOM LAR for a copy of MWO 11-5820-291-30-4. The MWO lists the software you need, tells how to install it and authorizes you to do it. Your LAR should also have a copy of the new software.
