CONNECT TO CORRECT CONNECTING LINK

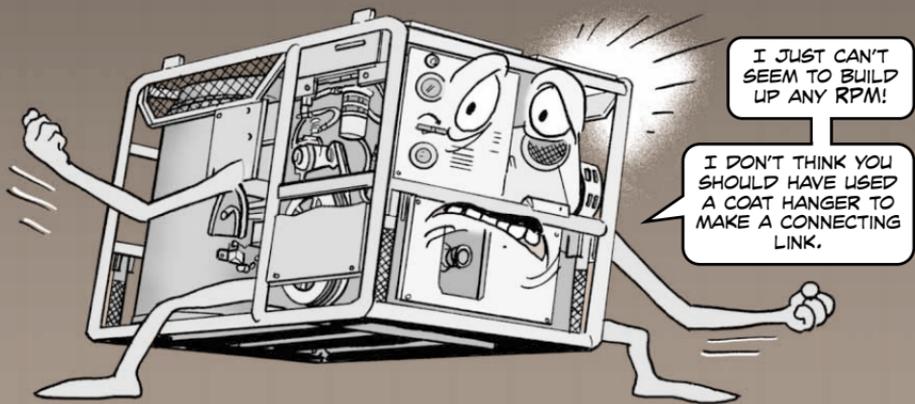
In my role as a roving troubleshooter/inspector for the M17-series decon, I find that 25 percent of the M17 connecting links between the carburetor and the engine vane are either missing or have had a piece of coat hanger substituted.

The result is the engine governor vane gets bent in the engine housing and the M17 engine can't reach high enough rpm to decon properly. There is no replacement vane. The only fix is to buy a whole new engine block for more than \$3,000.

If connecting link disappears, order a new one.

Before you order a new block, have your support remove the head nuts, washers, head gasket, and head to take out the vane. They can try to reshape the vane to its original shape and then reassemble the engine. The nuts must be torqued to 22-23 ft/lb.

Use the correct connecting link, NSN 3040-01-356-6947, and give the reshaped vane a try. If it works, you've saved \$3,000.

Never try to fabricate a connecting link. When a link is damaged or missing, order a new one. The link costs less than \$6. It's not worth risking a \$3,000 engine.
