# HEAT IS HARD ON TRACK

# KEEP THE COOL AIR FLOWING

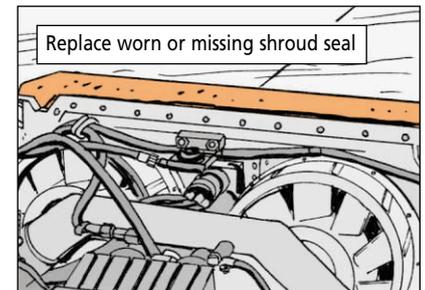
Those seals form an air barrier between the radiator and fan tower. That barrier increases air flow across the radiator to keep the engine cool. If seals are missing, torn, squashed or mangled, air escapes around the sides of the radiator. Engine temperature goes up.

Have your mechanic check out the shroud seals next time the pack's out. If the seals are missing or damaged, he'll order new ones.

NSN 5330-00-102-9927 gets a seal for the right or left side. NSN 5330-01-314-1439 gets a top or bottom seal for the M109A6 and the M992A2. A top or bottom seal for the M109A2-A5 comes with NSN 5330-00-899-5220.
