EXTRACTING A SOLUTION

M2/M3, M2A2/M3A2 Bradleys, MLRS Carrier...

16 LB-FT IS JUST RIGHT

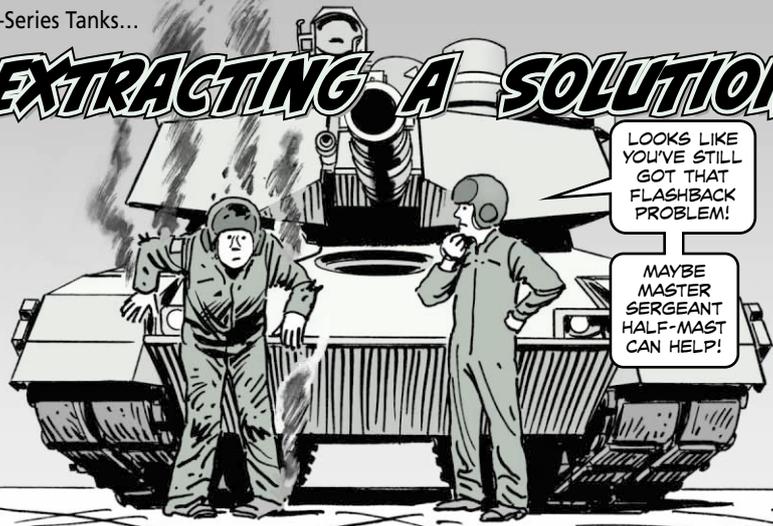
LOOKS LIKE YOU'VE STILL GOT THAT FLASHBACK PROBLEM!

Dear Half-Mast,
We're currently going through gunnery and have had some problems with one of our M1A1 tanks. When the tank fires, the breechblock doesn't drop to allow the aft cap to be ejected from the chamber. Since we have to manually extract the aft cap, there's the additional worry about unburnt propellant and gasses causing flashback in the turret.

If the cable is too far out of adjustment, the crank boss misses engagement with the cam bracket during the counter-recoil stroke. That's what mechanically cycles the breech open so the extractors can expel the aft cap.

If the ejection problem still exists after you adjust the cable, take a look at the extractors themselves. There is a small lip machined on the upper inside edge of each extractor. These lips are what grab the aft cap and extract it. If they wear down or break, they won't grab like they should.

Dear CW3 J.H.,
From what you've said, it sounds like you may need to adjust the cam bracket operation cable.

The adjustment procedures for the cam bracket operation cable start on Page 8-70 of TM 9-2350-264-20-2-4 (Apr 03), Page 8-55 of TM 9-2350-288-20-2-4 (Aug 95), and Page 8-61 of TM 9-2350-388-20-2-4 (Feb 01).

I'd also suggest that you manually exercise the mount. Use the M-3 oil pump and get the mount out far enough that the lobe on the crank extends past the cam (about 10 inches). With the manual handle in the armed (down) position, you should be able to see the cam snap into position. Then you can let the mount back into battery and watch the breech operation.

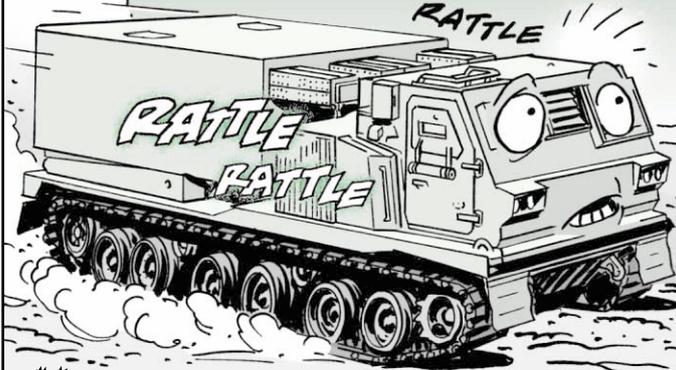
THE MECHANIC DIDN'T TORQUE MY GENERATOR'S OUTPUT STUD NUT TO 16 LB-FT!

As a result, some mechanics don't tighten the stud nut enough while others tighten it too much. Too loose and the nut will vibrate free. Too tight and the insulator may be damaged.

And no Loctite, either. That affects the torque value and can cause damage.

Mechanics, when you're working on the Bradley or MLRS' 300-amp generator, NSN 6115-01-458-0096, have some mercy on the output stud nut.
