TM Wrong on Mortar Clamp

MY TM—TM 9-2320-311-10-12—GIVES **BAD INFO** IN WP 0049 00 ON THE POSITION OF THE **MORTAR WIPER SEAL BAND CLAMP.**

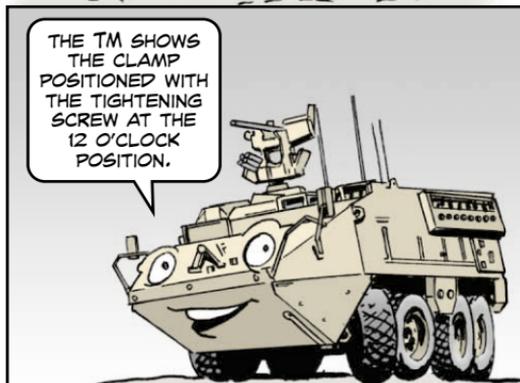
THE TM SHOWS THE CLAMP POSITIONED WITH THE TIGHTENING SCREW AT THE 12 O'CLOCK POSITION.

THE SCREW **SHOULD BE** AT THE 6 O'CLOCK POSITION. CHECK ALL YOUR STRYKERS WITH MORTARS FOR THE POSITION OF THE CLAMP.

IF ANY HAVE THE TIGHTENING SCREW IN THE 12 O'CLOCK POSITION, LOOSEN THE SCREW AND REPOSITION THE CLAMP SO THE SCREW IS AT 6 O'CLOCK.
