# WHAT ARE MASK MWOs?

## M40/M40A1/M42A2

## M45

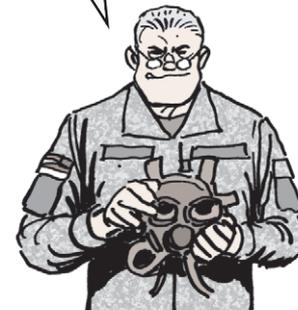
Zip tie

This MWO applied a retaining clamp (zip tie) to the facepiece to prevent the silicone rubber from separating from the outlet valve housing. The NBC NCO can do the MWO with a special tensioning tool that comes with the MWO kit. The kit also contains a set of PMCS cards that should be added to the carrier. All M40, M40A1, and M42A2 masks should have had this modification done by now.

If zip ties wear out, NBC NCOs should not local purchase new ones. For new ties, contact TACOM's Jim Morpewh at DSN 793-6415/(309) 782-6415 or email:
