Modern Burner Unit...

IF YOU CAN'T TAKE THE HEAT...

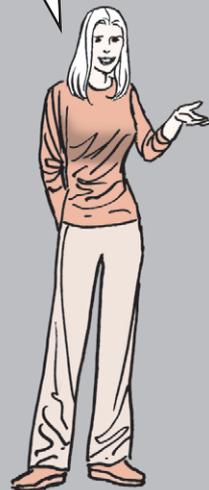
These high temperatures can play havoc with older versions of the modern burner unit (MBU) or MBUs that haven't been upgraded by MWO 7310-281-55-1. They can cause the flame sensor to fail. You need to replace the original sensor with an upgraded version that can withstand high kitchen temperatures.

AND HERE'S HOW TO REPLACE THE ORIGINAL FLAME SENSOR WITH THE UPGRADED ONE...

1. Cut off power to the MBU. Make sure the MBU is cool.

2. Open the control panel.

3. Using a cross tip screwdriver, remove the two screws and lock-washers holding the flame sensor to the fuel delivery block.

4. Unplug the sensor's wiring harness connector.
5. Install the replacement sensor on the fuel delivery block. Tighten the two screws and lock washers.

6. Plug in the sensor's wiring harness connector.
