# Clamp It Down

PS 647

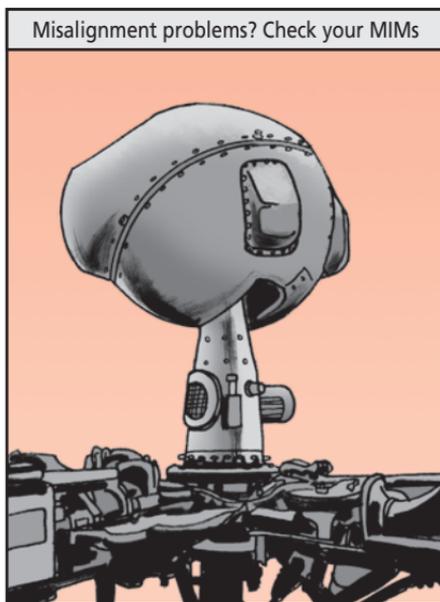
**M**echanics, the black clamps on the inside of your Kiowa Warrior's mast mounted sight (MMS) may contribute to alignment problems because some of the bolts used to secure the black clamps bottom out before the clamps can be adequately tightened. This condition may contribute to a misalignment of the upper and lower MMS shrouds. There are corrective actions, OH-58D-MIM-05-006, that can be taken to alleviate this problem and allow the black clamps to be considered as serviceable.

There are also new clamps available that are green in color, NSN 1260-01-521-7683, and have tighter tolerances than the old black clamps, NSN 1260-01-227-7480.

The green clamps prevent the bolts from bottoming out. That lets the clamps grip the upper and lower shroud cover flange without using washers.

The old black and the new green clamps can be used in combination. Wear on the upper and lower flange will determine if you need a washer when you use the black clamps. So units should continue to order the old clamps until the stock is exhausted. You can find all this good info in OH-58D-MIM-2005-024, -006 and -008.

Make a note until TM 9-1240-778-23 is updated.
