MODIFICATION AWARENESS

There's a modification for some 18K BTU environmental control units (ECU), NSN 4120-01-327-1316, so they can work properly in signal shelters. The modification was made to the thermistor because of poor ductwork in those shelters. The lack of proper ductwork kept the ECU short-cycling.

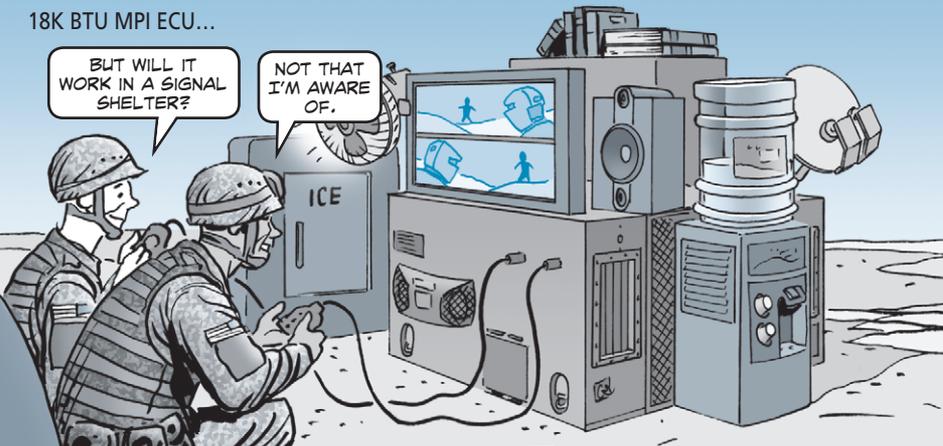
Unfortunately, for reasons like careless painting and loss, that data plate is often unreadable. When a modified ECU is placed on a non-modified shelter, the compressor will not come on in the cool mode and the temperature will become uncontrollable.

Look for the modification data plate

Handwritten note: This is the modification data plate. It is located under the standard data plate on the ECU.

Plate may be covered over
