THE WORD IS OUT

CH-47D/UH-60 Series...

BLACK HAWKS AND CHINOOKS, YOUR RADARS ARE BEING MODIFIED!

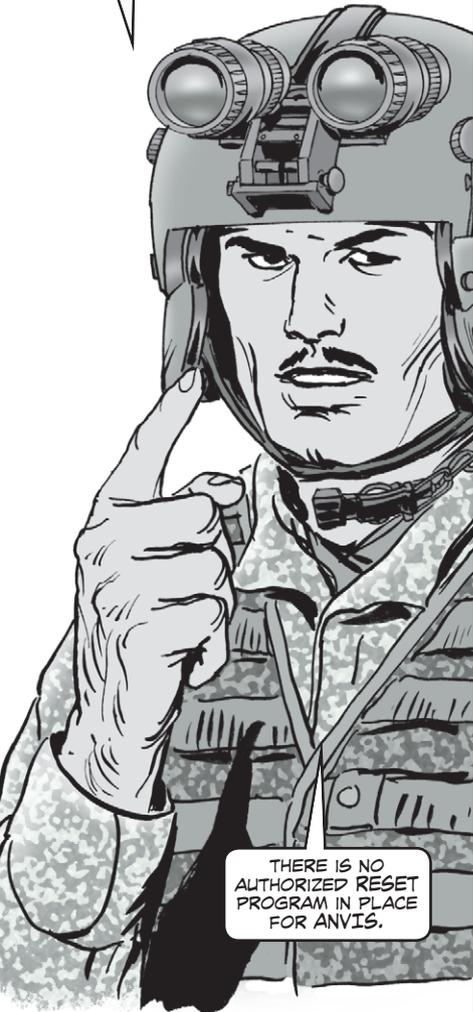
THERE IS NO AUTHORIZED RESET PROGRAM IN PLACE FOR ANVIS.

Maintenance can be performed **only** by an authorized AVIM, AASF, ASF, or LAD shop. **Do not** ship the ANVIS to unauthorized maintenance facilities claiming to perform RESET, or to people who are not properly trained to perform maintenance. The only authorized ANVIS maintainers are listed in GEN-06-0-02.

ANVIS returned from unauthorized 'RESET' teams have had maintenance performed without being documented. Other problems have included improper collimation, no purging and incorrect zero diopter settings and infinity focus. Doin' your own maintenance on binoculars must stop!

Upon returning from your deployment, service your binoculars at the normally scheduled six-month intervals like it says in TM 11-5855-263-23&P and TM 11-5855-313-23&P.

Any ANVIS turned into an unauthorized program must be reinspected by a qualified inspector to ensure the -10/20 standards are met.

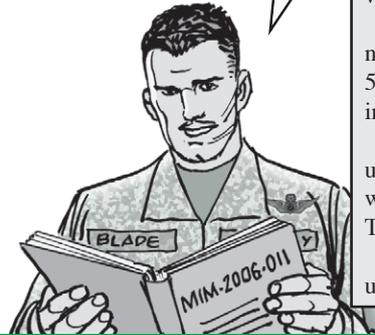
Pages 35-37 of PS 643, June 2006, tells you what you can—and cannot—do to take care of your ANVIS. But there are a few changes since that article was published.

The objective lens and eyepiece assemblies should not be loose but have free movement. Update TM 11-5855-263-10 and TM 11-5855-313-10 with pen and ink changes from GEN-06-ASAM-02.

When performing the power pack test, attach or update the gummed label, NSN 7530-01-514-4913, with the due date for the next inspection like it says in TM 11-5855-263-23&P and TM 11-5855-313-23&P.

Make a note until all changes to the TMs are updated.

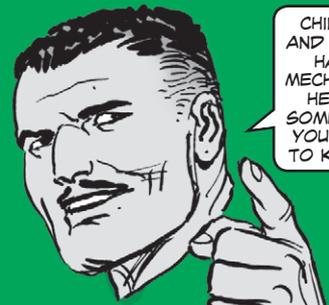
If your CH-47 and UH-60 has had either MWO 1-1520-240-50-90 or MWO 1-1520-237-50-84 applied, then you have the AN/APX-118 common transponder, NSN 5895-01-504-0407.

That means the battery replacement requirement has changed. For the new transponder battery, NSN 1635-01-529-0122, there is no specified battery time change requirement.

The status of the new battery is not checked during normal operation and can only be determined through the power up bit (PUBIT) status.

The BATTERY LOW status and FAULT indicator are displayed on the RCU. The LOW BTRY LED will illuminate on the transponder. When the LOW BTRY LED first lights up, replace the battery prior to the next mission.

Make a note that requisitions for the old battery, NSN 1680-01-493-8794, will be cancelled.
