Rub Out Steering Leaks

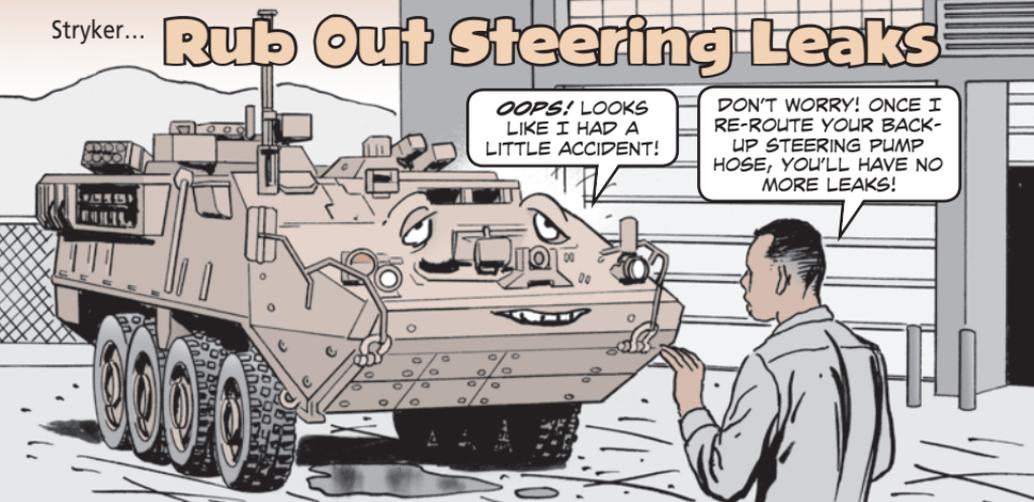
Mechanics, are you getting reports of low steering fluid in your unit's Strykers? Could be that the backup steering pump hose is getting a little too familiar with the drive shaft on those vehicles.

On some Strykers, there's not enough clearance between the drive shaft and the hose. That causes rubbing that leads to leaks.

During each Stryker's next scheduled maintenance, open the rear engine access panel and look at the rear of the power pack where the drive shaft connects to the transfer case. If the backup steering pump hose is touching the drive shaft, tie the hose to the main steering and auxiliary hoses using two cable ties, NSN 5975-00-984-6582.

To remind you of the new routing for the backup steering pump hose, a note is being added to the procedures for removal and installation of the power pack. See the Power Pack Assembly Replacement section of IETM 9-2355-311-13&P for more information on proper routing of the hose.
