Geared Hub Washers Can Deadline

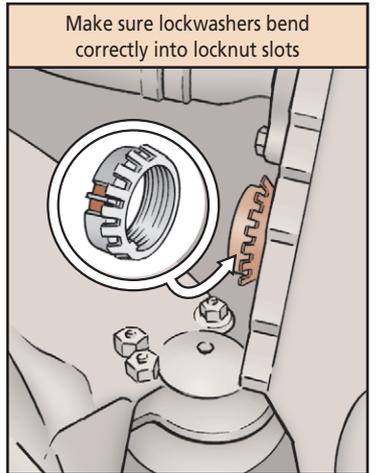
This isn't a new problem, but it's one that bears repeating. If your HMMWV's geared hub lockwashers are not bent properly into the locknut slots, then the tabs are more likely to crack or break off. That increases the chances that the locknut will loosen and come off, which could cause a wheel to fall off.

And if the washer was installed incorrectly, the lock tabs may not seat fully in the lockwasher slots. Then the spindle lock nut may back off in the hub assembly and your HMMWV could lose a wheel while moving. So pay attention to detail when installing geared hub lockwashers.

Remember the bottom line the next time you need to replace your lockwasher. After everything is tightened, make sure that the tabs are bent correctly into the slots in the nut. That can prevent a deadlined HMMWV.
