# Gearbox Servicing Plug

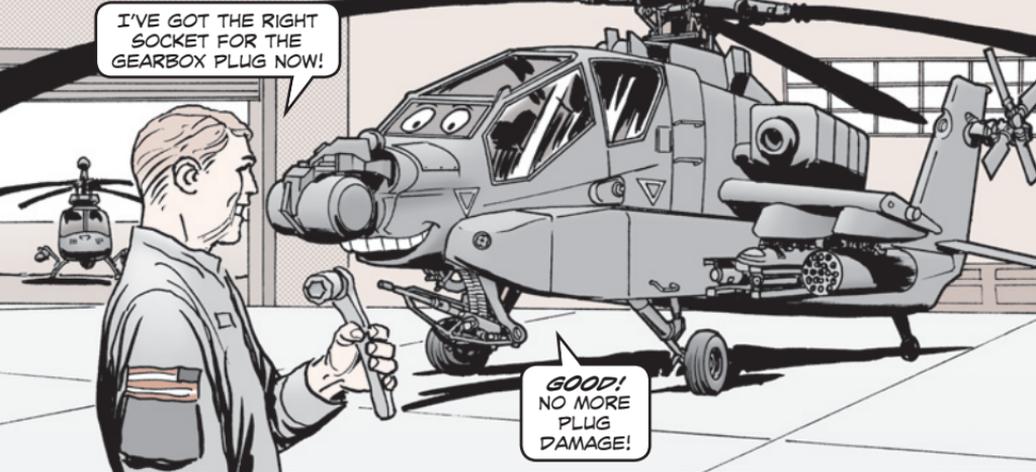
Removing the servicing grease plug from the AH-64's intermediate gearbox with a wrench and socket from the aviation foot locker is a tough job, mechanics. Especially if it's not a good fit.

Problem is, the TM 1-1520-Longbow Apache IETM says to use a socket from the locker. But to use it, mechanics have to shave down the inside of the socket to force it to fit. But that creates more work and the socket still won't fit properly anyway.

In the end, after all the shaving is done, the servicing plug usually gets worn out, stripped or damaged after it's removed from the intermediate gearbox.

Get rid of your plug problem removal by ordering a 1 <sup>5</sup>/<sub>16</sub>-in socket, NSN 5120-01-335-0855, that's a perfect fit.

Save the plug and get the right socket.
